Access Compliance Report

Public Rights-of-Way

(Curb Ramps)

Intersection ID: N/A	Main Street: SOUTHMORE_DR	Cross Street: HOUSTONFIELD CT	Location: NE
ADA ID: D0A3CF19748D	Ramp Type: Perp	Initial Pass/Fail: Fail	Overall Compliance: No
Severity Score: 12.5			
Codes/Mitigation Info/Possible Solution		Field Measurements/Component Compliance

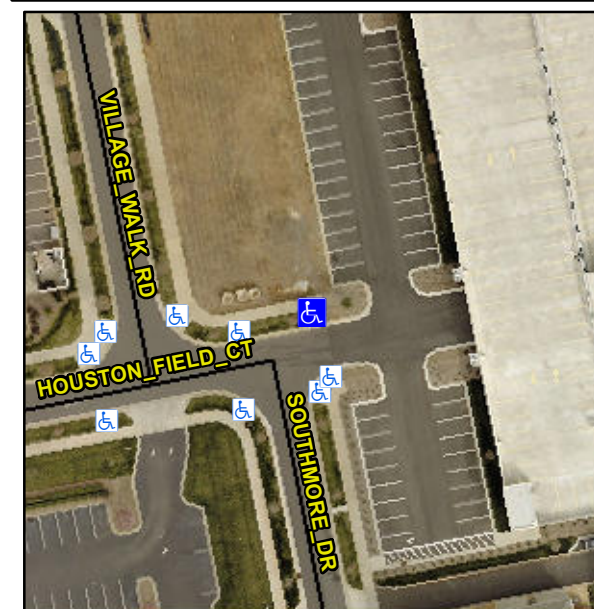
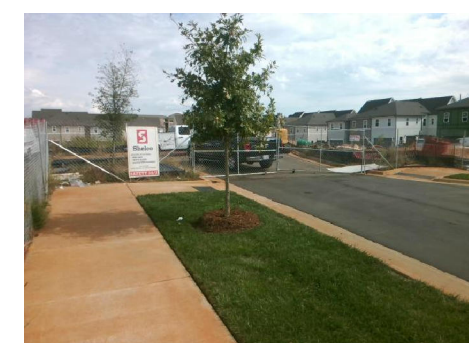
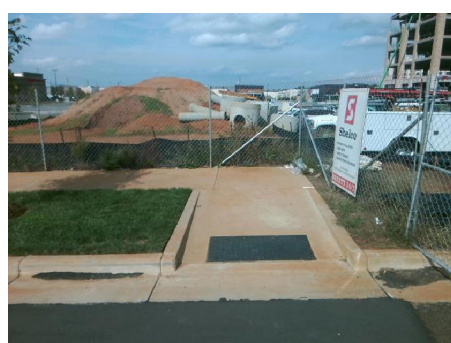
R304.2.2

Compliance	Description	Data	Compliance	Description	Data
N/A	Ramp Length (in)	94.0	No	Ramp Slope (%)	9.6
Yes	Ramp Width (in)	72.0	Yes	Ramp XSlope (%)	2.0
N/A	Flare Type LT	N/A	N/A	Flare Type RT	N/A
N/A	Flare Slope LT (%)	N/A	N/A	Flare Slope RT (%)	N/A
N/A	Flare Traversable LT?	N/A	N/A	Flare Traversable RT?	N/A
N/A	Landing Length (in)	N/A	N/A	DWS Provided?	N/A
N/A	Landing Width (in)	N/A	N/A	DWS Contrast?	N/A
N/A	Landing Slope (%)	N/A	N/A	DWS Length (in)	N/A
N/A	Landing X Slope (%)	N/A	N/A	DWS Full Width?	N/A
N/A	Landing Curb? (Y/N)	N/A	N/A	DWS Offset (in)	N/A
N/A	Shared Landing?	N/A			
N/A	Gutter Ponding?	N/A	N/A	Gutter Slope (%)	N/A
N/A	Gutter Lip Ht (in)	N/A	N/A	Gutter X Slope (%)	N/A
N/A	Painted X Walk1?	No	N/A	Painted X Walk2?	N/A
	X Walk 1 Direction	To S		X Walk 2 Direction	N/A
N/A	X Walk 1 Width (in)	N/A	N/A	X Walk 2 Width (in)	N/A
	X Walk 1 Slope (%)	1.7		X Walk 2 Slope (%)	N/A
	X Walk 1 X Slope (%)	4.7		X Walk 2 X Slope (%)	N/A

N/A	Ramp inside XWalk1?	N/A	N/A	Ramp inside XWalk2?	N/A
	Road Slope (%)	N/A	N/A	Clear Space?	N/A
	Road X Slope (%)	N/A	N/A	Clear Space to XWalk (in)	N/A
N/A	Any Obstructions?	N/A	N/A	Storm Grate/Utility Hazard?	N/A
	Obstruction Type			Storm Grate/Utility Type	
		N/A			N/A
			Yes	Surface Condition? (G/P)	Good

Remove & Replace Entire Ramp.

Total Cost: \$ 1850.00
