Access Compliance Report

Public Rights-of-Way

(Curb Ramps)

Intersection ID: 11824	Main Street: W_8TH_ST	Cross Street: N_CHURCH_ST	Location: E
ADA ID: D0B0E23C1AD9	Ramp Type: PerpDiag	Initial Pass/Fail: Fail	Overall Compliance: No
Severity Score: 8.75			
Codes/Mitigation Info/Possible Solution		Field Measurements/Component Compliance

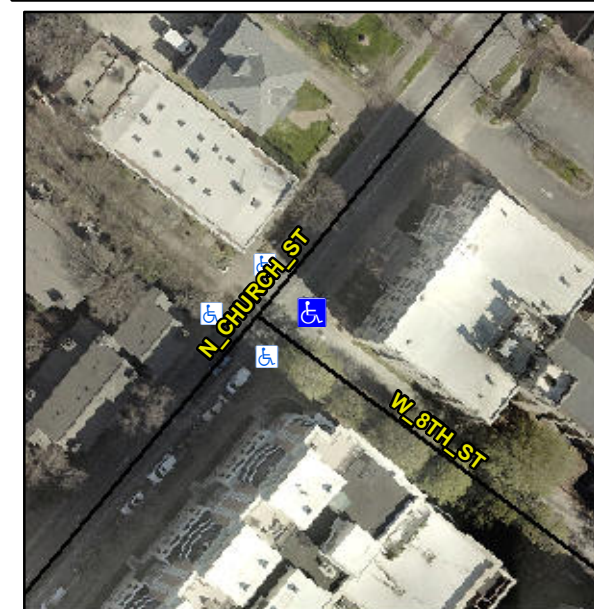
Compliance	Description	Data	Compliance	Description	Data
N/A	Ramp Length (in)	36.0	Yes	Ramp Slope (%)	6.1
No	Ramp Width (in)	45.0	Yes	Ramp XSlope (%)	1.7
N/A	Flare Type LT	N/A	N/A	Flare Type RT	N/A
N/A	Flare Slope LT (%)	N/A	N/A	Flare Slope RT (%)	N/A
N/A	Flare Traversable LT?	N/A	N/A	Flare Traversable RT?	N/A
N/A	Landing Length (in)	N/A	N/A	DWS Provided?	N/A
N/A	Landing Width (in)	N/A	N/A	DWS Contrast?	N/A
N/A	Landing Slope (%)	N/A	N/A	DWS Length (in)	N/A
N/A	Landing X Slope (%)	N/A	N/A	DWS Full Width?	N/A
N/A	Landing Curb? (Y/N)	N/A	N/A	DWS Offset (in)	N/A
N/A	Shared Landing?	N/A			
N/A	Gutter Ponding?	N/A	N/A	Gutter Slope (%)	N/A
N/A	Gutter Lip Ht (in)	N/A	N/A	Gutter X Slope (%)	N/A
N/A	Painted X Walk1?	No	N/A	Painted X Walk2?	No
	X Walk 1 Direction	To NW		X Walk 2 Direction	To SW
N/A	X Walk 1 Width (in)	N/A	N/A	X Walk 2 Width (in)	N/A
	X Walk 1 Slope (%)	1.4		X Walk 2 Slope (%)	4.3
	X Walk 1 X Slope (%)	2.5		X Walk 2 X Slope (%)	0.3

N/A	Ramp inside XWalk1?	N/A	N/A	Ramp inside XWalk2?	N/A
	Road Slope (%)	0.8	N/A	Clear Space?	N/A
	Road X Slope (%)	4.6	N/A	Clear Space to XWalk (in)	N/A
N/A	Any Obstructions?	N/A	N/A	Storm Grate/Utility Hazard?	N/A
	Obstruction Type			Storm Grate/Utility Type	
		N/A			N/A
			Yes	Surface Condition? (G/P)	Good

Remove & Replace Curb Ramp With Two New Directional Ramps or Equivalent.

R304.5.1
