# Access Compliance Report

## Public Rights-of-Way

### (Curb Ramps)

Intersection ID: 28081	Main Street: PROVIDENCE_GREEN_CT	Cross Street: SHOAL_BROOK_CT	Location: NE
ADA ID: D0B16B7AC75C	Ramp Type: Perp	Initial Pass/Fail: Fail	Overall Compliance: No
Severity Score: 10			
Codes/Mitigation Info/Possible Solution		Field Measurements/Component Compliance

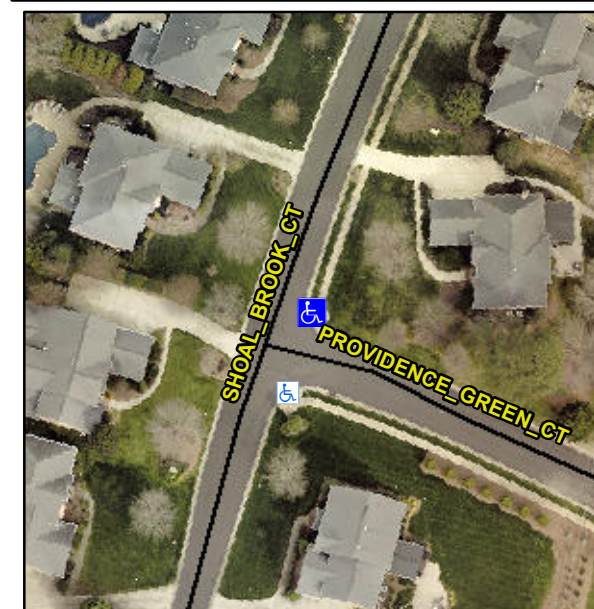
**Not Found, R304.5.1, R304.5.3**

Compliance	Description	Data	Compliance	Description	Data
N/A	Ramp Length (in)	47.0	Yes	Ramp Slope (%)	7.4
No	Ramp Width (in)	40.0	No	Ramp XSlope (%)	3.8
N/A	Flare Type LT	N/A	N/A	Flare Type RT	N/A
N/A	Flare Slope LT (%)	N/A	N/A	Flare Slope RT (%)	N/A
N/A	Flare Traversable LT?	N/A	N/A	Flare Traversable RT?	N/A
N/A	Landing Length (in)	N/A	N/A	DWS Provided?	N/A
N/A	Landing Width (in)	N/A	N/A	DWS Contrast?	N/A
N/A	Landing Slope (%)	N/A	N/A	DWS Length (in)	N/A
N/A	Landing X Slope (%)	N/A	N/A	DWS Full Width?	N/A
N/A	Landing Curb? (Y/N)	N/A	N/A	DWS Offset (in)	N/A
N/A	Shared Landing?	N/A			
N/A	Gutter Ponding?	N/A	N/A	Gutter Slope (%)	N/A
N/A	Gutter Lip Ht (in)	N/A	N/A	Gutter X Slope (%)	N/A
N/A	Painted X Walk1?	No	N/A	Painted X Walk2?	N/A
	X Walk 1 Direction	To SW		X Walk 2 Direction	N/A
N/A	X Walk 1 Width (in)	N/A	N/A	X Walk 2 Width (in)	N/A
	X Walk 1 Slope (%)	1.7		X Walk 2 Slope (%)	N/A
	X Walk 1 X Slope (%)	2.0		X Walk 2 X Slope (%)	N/A

N/A	Ramp inside XWalk1?	N/A	N/A	Ramp inside XWalk2?	N/A
	Road Slope (%)	N/A	N/A	Clear Space?	N/A
	Road X Slope (%)	N/A	N/A	Clear Space to XWalk (in)	N/A
N/A	Any Obstructions?	N/A	N/A	Storm Grate/Utility Hazard?	N/A
	Obstruction Type			Storm Grate/Utility Type	
		N/A			N/A
			Yes	Surface Condition? (G/P)	Good

**Remove & Replace Entire Ramp.**
