Access Compliance Report

Public Rights-of-Way

(Curb Ramps)

Intersection ID: 31206	Main Street: WESTBURY_GLEN_CT	Cross Street: LARIMER_LN	Location: E
ADA ID: D0B259ECA3EF	Ramp Type: PerpDiag	Initial Pass/Fail: Fail	Overall Compliance: No
Codes/Mitigation Info/Possible Solution		Field Measurements/Component Compliance

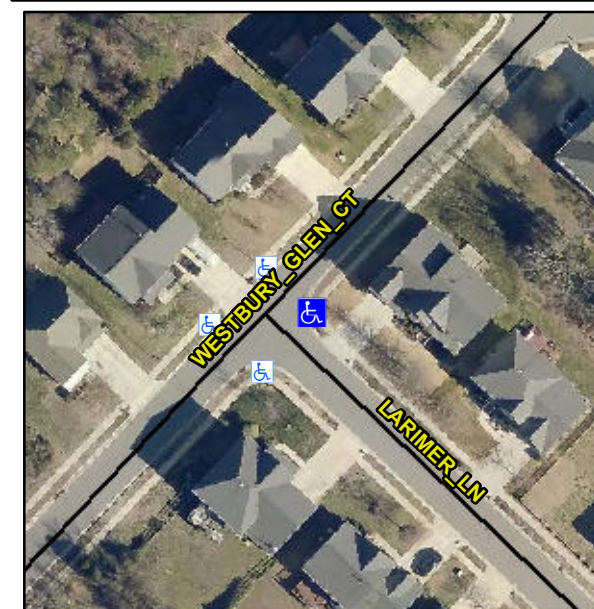
Not Found, R304.5.1, R304.5.3

Compliance	Description	Data	Compliance	Description	Data
N/A	Ramp Length (in)	48.0	Yes	Ramp Slope (%)	5.0
No	Ramp Width (in)	40.0	No	Ramp XSlope (%)	8.6
N/A	Flare Type LT	N/A	N/A	Flare Type RT	N/A
N/A	Flare Slope LT (%)	N/A	N/A	Flare Slope RT (%)	N/A
N/A	Flare Traversable LT?	N/A	N/A	Flare Traversable RT?	N/A
N/A	Landing Length (in)	N/A	N/A	DWS Provided?	N/A
N/A	Landing Width (in)	N/A	N/A	DWS Contrast?	N/A
N/A	Landing Slope (%)	N/A	N/A	DWS Length (in)	N/A
N/A	Landing X Slope (%)	N/A	N/A	DWS Full Width?	N/A
N/A	Landing Curb? (Y/N)	N/A	N/A	DWS Offset (in)	N/A
N/A	Shared Landing?	N/A			
N/A	Gutter Ponding?	N/A	N/A	Gutter Slope (%)	N/A
N/A	Gutter Lip Ht (in)	N/A	N/A	Gutter X Slope (%)	N/A
N/A	Painted X Walk1?	No	N/A	Painted X Walk2?	No
	X Walk 1 Direction	To NW		X Walk 2 Direction	To SW
N/A	X Walk 1 Width (in)	N/A	N/A	X Walk 2 Width (in)	N/A
	X Walk 1 Slope (%)	0.8		X Walk 2 Slope (%)	9.0
	X Walk 1 X Slope (%)	8.3		X Walk 2 X Slope (%)	4.6

N/A	Ramp inside XWalk1?	N/A	N/A	Ramp inside XWalk2?	N/A
	Road Slope (%)	7.9	N/A	Clear Space?	N/A
	Road X Slope (%)	1.8	N/A	Clear Space to XWalk (in)	N/A
N/A	Any Obstructions?	N/A	N/A	Storm Grate/Utility Hazard?	N/A
	Obstruction Type			Storm Grate/Utility Type	
		N/A			N/A
			Yes	Surface Condition? (G/P)	Good

Remove & Replace Curb Ramp With Two New Directional Ramps or Equivalent.
