Access Compliance Report

Public Rights-of-Way

(Curb Ramps)

Intersection ID: 12160	Main Street: E_9TH_ST	Cross Street: N_BREVARD_ST	Location: N
ADA ID: D0B63E3F9EB6	Ramp Type: BlendTrans1	Initial Pass/Fail: Fail	Overall Compliance: No
			Severity Score: 21.25

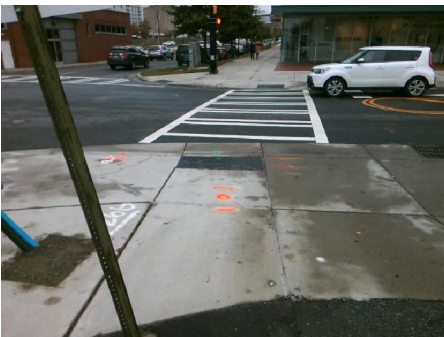
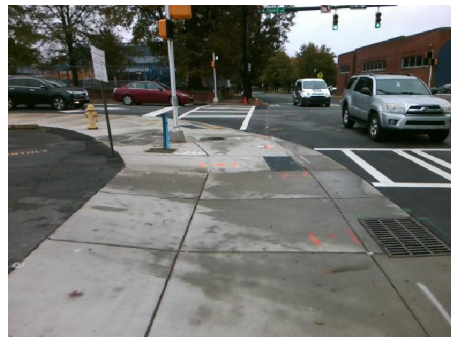
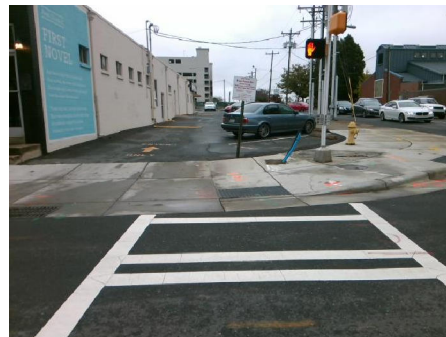
Compliance	Description	Data	Compliance	Description	Data
N/A	Ramp Length (in)	72.0	Yes	BlendTrans Slope (%)	3.3
No	Ramp Width (in)	47.0	No	BlendTrans XSlope (%)	5.6
N/A	Flare Type LT	N/A	N/A	Flare Type RT	N/A
N/A	Flare Slope LT (%)	N/A	N/A	Flare Slope RT (%)	N/A
N/A	Flare Traversable LT?	N/A	N/A	Flare Traversable RT?	N/A
N/A	Landing Length (in)	N/A	N/A	DWS Provided?	N/A
N/A	Landing Width (in)	N/A	N/A	DWS Contrast?	N/A
N/A	Landing Slope (%)	N/A	N/A	DWS Length (in)	N/A
N/A	Landing X Slope (%)	N/A	N/A	DWS Full Width?	N/A
N/A	Landing Curb? (Y/N)	N/A	N/A	DWS Offset (in)	N/A
N/A	Shared Landing?	N/A			
N/A	Gutter Ponding?	N/A	N/A	Gutter Slope (%)	N/A
N/A	Gutter Lip Ht (in)	N/A	N/A	Gutter X Slope (%)	N/A
N/A	Painted X Walk1?	Yes	N/A	Painted X Walk2?	N/A
	X Walk 1 Direction	To SW		X Walk 2 Direction	N/A
	X Walk 1 Width (in)	104.0		X Walk 2 Width (in)	N/A
	X Walk 1 Slope (%)	1.4		X Walk 2 Slope (%)	N/A
	X Walk 1 X Slope (%)	0.5		X Walk 2 X Slope (%)	N/A

N/A	Ramp inside XWalk1?	Yes	N/A	Ramp inside XWalk2?	N/A
	Road Slope (%)	0.5		Clear Space?	N/A
	Road X Slope (%)	1.4	N/A	Clear Space to XWalk (in)	N/A
N/A	Any Obstructions?	N/A	N/A	Storm Grate/Utility Hazard?	N/A
	Obstruction Type			Storm Grate/Utility Type	
		N/A			N/A
			Yes	Surface Condition? (G/P)	Good
			N/A	Curb Slope (%)	4.9

Remove & Replace Curb Ramp With Two New Directional Ramps or Equivalent.
