# Access Compliance Report

## Public Rights-of-Way

### (Curb Ramps)

Intersection ID: 10123	Main Street: GLENWOOD_DR	Cross Street: TUCKASEEGEE_RD	Location: N
ADA ID: D0B6941F634D	Ramp Type: Para	Initial Pass/Fail: Fail	Overall Compliance: No
Codes/Mitigation Info/Possible Solution		Field Measurements/Component Compliance

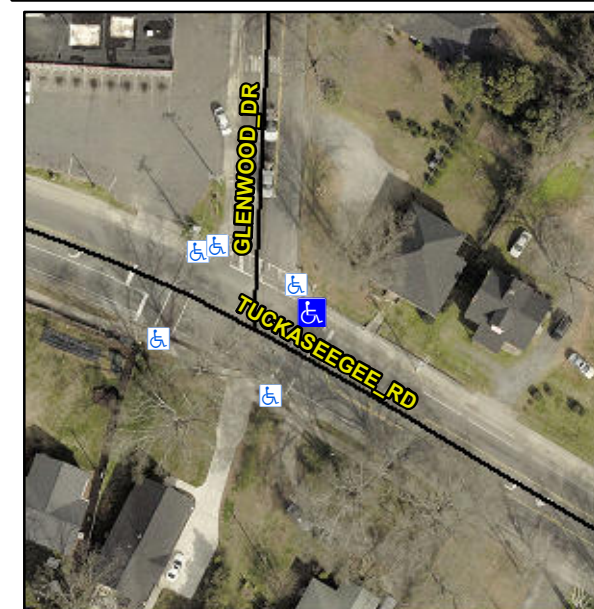
**LT RP < 5%**

PROW/ADA:

**R304.3.2, R304.5.3**

Compliance	Description	Data	Compliance	Description	Data
N/A	Ramp Length LT (in)	60.0	N/A	Ramp Length RT (in)	81.0
Yes	Ramp Width LT (in)	71.0	Yes	Ramp Width RT (in)	71.0
Yes	Ramp Slope LT (%)	2.1	No	Ramp Slope RT (%)	8.4
Yes	Ramp XSlope LT (%)	1.3	No	Ramp XSlope RT (%)	2.7
N/A	Landing Length (in)	N/A	N/A	DWS Provided?	N/A
N/A	Landing Width (in)	N/A	N/A	DWS Contrast?	N/A
N/A	Landing Slope (%)	N/A	N/A	DWS Length (in)	N/A
N/A	Landing X Slope (%)	N/A	N/A	DWS Full Width?	N/A
N/A	Landing Curb? (Y/N)	N/A	N/A	DWS Offset (in)	N/A
N/A	Shared Landing?	N/A			
N/A	Gutter Ponding?	N/A	N/A	Gutter Slope (%)	N/A
N/A	Gutter Lip Ht (in)	N/A	N/A	Gutter X Slope (%)	N/A
N/A	Painted X Walk1?	Yes	N/A	Painted X Walk2?	N/A
	X Walk 1 Direction	To S		X Walk 2 Direction	N/A
N/A	X Walk 1 Width (in)	114.0	N/A	X Walk 2 Width (in)	N/A
	X Walk 1 Slope (%)	7.5		X Walk 2 Slope (%)	N/A
	X Walk 1 X Slope (%)	1.1		X Walk 2 X Slope (%)	N/A
N/A	Ramp inside XWalk1?	Yes	N/A	Ramp inside XWalk2?	N/A

Road Slope (%)	N/A	N/A	Clear Space?	N/A
	Road X Slope (%)	N/A	N/A	Clear Space to XWalk (in)	N/A
N/A	Any Obstructions?	N/A	N/A	Storm Grate/Utility Hazard?	N/A
	Obstruction Type			Storm Grate/Utility Type	
		N/A			N/A
			Yes	Surface Condition? (G/P)	Good
			N/A	Curb Slope (%)	12.5

Possible Solutions:

**Remove & Replace Entire Ramp.**

Total Cost: \$ 1600.00
