Access Compliance Report

Public Rights-of-Way

(Curb Ramps)

Intersection ID: 4298	Main Street: OLD_STATESVILLE_RD	Cross Street: TWIN_DR	Location: W
ADA ID: D0B8F14B1A46	Ramp Type: Perp	Initial Pass/Fail: Fail	Overall Compliance: No
Severity Score: 21.25			
Codes/Mitigation Info/Possible Solution		Field Measurements/Component Compliance

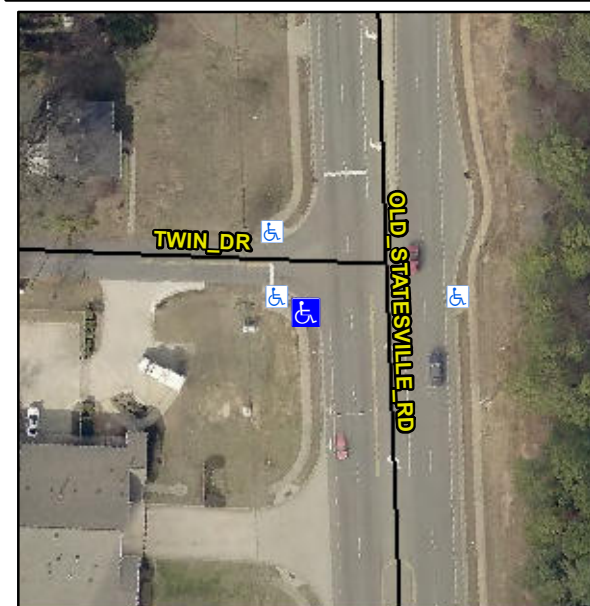
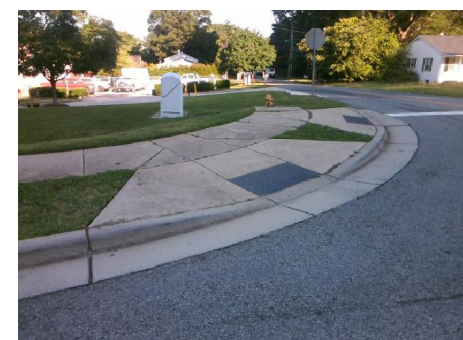
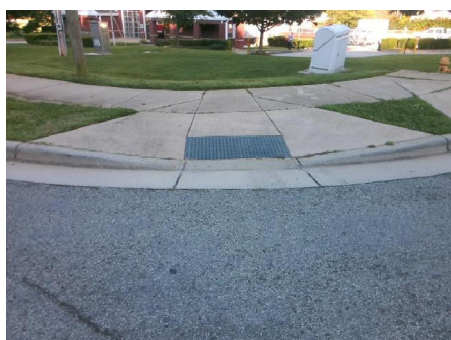
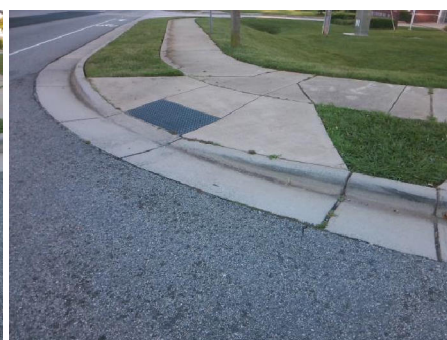
Not Found, R304.5.1, R304.2.2

Compliance	Description	Data	Compliance	Description	Data
N/A	Ramp Length (in)	60.0	No	Ramp Slope (%)	9.5
No	Ramp Width (in)	40.5	Yes	Ramp XSlope (%)	1.7
N/A	Flare Type LT	N/A	N/A	Flare Type RT	N/A
N/A	Flare Slope LT (%)	N/A	N/A	Flare Slope RT (%)	N/A
N/A	Flare Traversable LT?	N/A	N/A	Flare Traversable RT?	N/A
N/A	Landing Length (in)	N/A	N/A	DWS Provided?	N/A
N/A	Landing Width (in)	N/A	N/A	DWS Contrast?	N/A
N/A	Landing Slope (%)	N/A	N/A	DWS Length (in)	N/A
N/A	Landing X Slope (%)	N/A	N/A	DWS Full Width?	N/A
N/A	Landing Curb? (Y/N)	N/A	N/A	DWS Offset (in)	N/A
N/A	Shared Landing?	N/A			
N/A	Gutter Ponding?	N/A	N/A	Gutter Slope (%)	N/A
N/A	Gutter Lip Ht (in)	N/A	N/A	Gutter X Slope (%)	N/A
N/A	Painted X Walk1?	No	N/A	Painted X Walk2?	N/A
	X Walk 1 Direction	To E		X Walk 2 Direction	N/A
N/A	X Walk 1 Width (in)	N/A	N/A	X Walk 2 Width (in)	N/A
	X Walk 1 Slope (%)	0.7		X Walk 2 Slope (%)	N/A
	X Walk 1 X Slope (%)	2.2		X Walk 2 X Slope (%)	N/A

N/A	Ramp inside XWalk1?	N/A	N/A	Ramp inside XWalk2?	N/A
	Road Slope (%)	N/A	N/A	Clear Space?	N/A
	Road X Slope (%)	N/A	N/A	Clear Space to XWalk (in)	N/A
N/A	Any Obstructions?	N/A	N/A	Storm Grate/Utility Hazard?	N/A
	Obstruction Type			Storm Grate/Utility Type	
		N/A			N/A
			Yes	Surface Condition? (G/P)	Good

Possible Solutions:

Remove & Replace Entire Ramp.

Total Cost: \$ 1850.00
