# Access Compliance Report

## Public Rights-of-Way

### (Curb Ramps)

Intersection ID: 10040558	Main Street: W_8TH_ST	Cross Street: N/A	Location: E
ADA ID: D0B9091F1239	Ramp Type: Directional2	Initial Pass/Fail: Pass	Overall Compliance: No
			Severity Score: 10.25

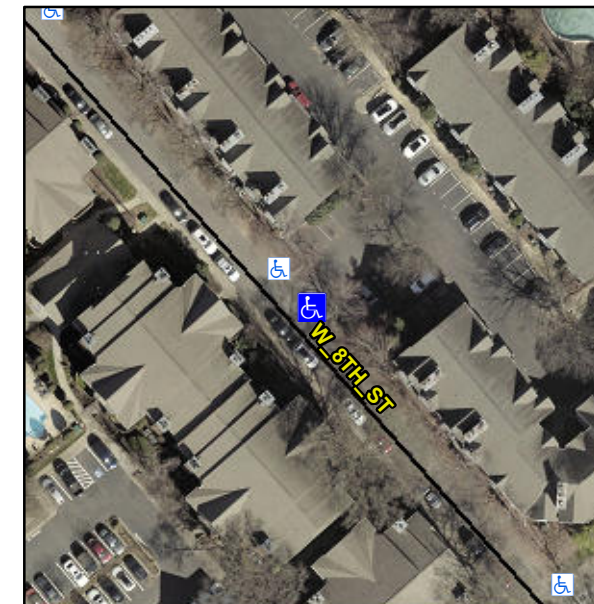
PROW/ADA:

**R304.5.3, R305**

Compliance	Description	Data	Compliance	Description	Data
N/A	Ramp Length (in)	46.0	Yes	Grade Break?	Yes
Yes	Ramp Width (in)	53.0	Yes	Grade Break Slope (%)	2.0
Yes	Ramp Slope (%)	4.8	Yes	Grade Break XSlope (%)	1.1
No	Ramp XSlope (%)	3.3			
N/A	Flare Type LT	N/A	N/A	Flare Type RT	N/A
N/A	Flare Slope LT (%)	N/A	N/A	Flare Slope RT (%)	7.7
N/A	Flare Traversable LT?	N/A	N/A	Flare Traversable RT?	Yes
Yes	Landing Length (in)	60.0	No	DWS Provided?	No
Yes	Landing Width (in)	59.0	N/A	DWS Contrast?	No
Yes	Landing Slope (%)	0.1	N/A	DWS Length (in)	N/A
Yes	Landing X Slope (%)	0.2	N/A	DWS Full Width?	No
N/A	Landing Curb? (Y/N)	N/A	N/A	DWS Offset LT (in)	N/A
N/A	Shared Landing?	No	N/A	DWS Offset RT (in)	N/A
Yes	Gutter Ponding?	No	Yes	Gutter Slope (%)	4.0
Yes	Gutter Lip Ht (in)	0.0	Yes	Gutter X Slope (%)	0.8
N/A	Painted X Walk1?	No		Road Slope (%)	0.9
	X Walk 1 Direction	To NW		Road X Slope (%)	0.2
	X Walk 1 Width (in)	N/A		Clear Space?	Yes

X Walk 1 Slope (%)	0.9	N/A	Clear Space to XWalk (in)	N/A
	X Walk 1 X Slope (%)	0.2	Yes	Storm Grate/Utility Hazard?	No
N/A	Ramp inside XWalk1?	N/A		Storm Grate/Utility Type	
Yes	Any Obstructions?	No			N/A
	Obstruction Type		Yes	Surface Condition? (G/P)	Good
			N/A	Curb Slope (%)	2.0

Possible Solutions:

**Remove & Replace Entire Ramp.**
