Access Compliance Report

Public Rights-of-Way

(Curb Ramps)

Intersection ID: 50867	Main Street: REAMES_RD	Cross Street: BROOKLINE_RIDGE_DR	Location: W
ADA ID: D0CBAE2E9A51	Ramp Type: Perp	Initial Pass/Fail: Fail	Overall Compliance: No
Severity Score: 10			
Codes/Mitigation Info/Possible Solution		Field Measurements/Component Compliance

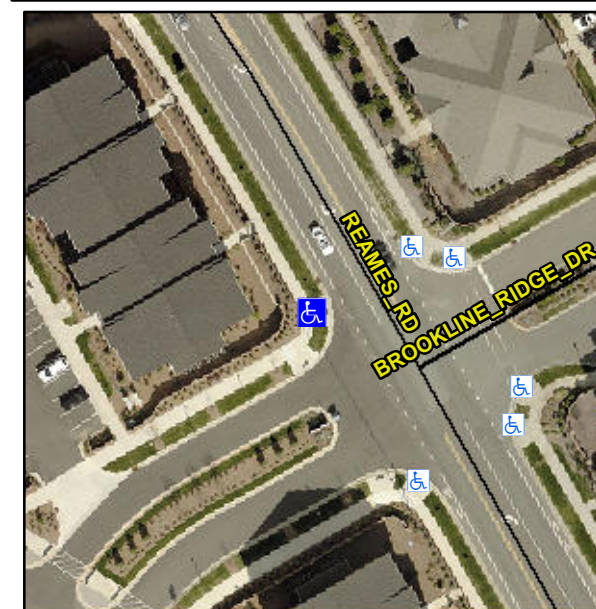
Not Found, R304.5.1, R304.5.3

Compliance	Description	Data	Compliance	Description	Data
N/A	Ramp Length (in)	72.5	Yes	Ramp Slope (%)	8.3
No	Ramp Width (in)	47.0	No	Ramp XSlope (%)	2.1
N/A	Flare Type LT	N/A	N/A	Flare Type RT	N/A
N/A	Flare Slope LT (%)	N/A	N/A	Flare Slope RT (%)	N/A
N/A	Flare Traversable LT?	N/A	N/A	Flare Traversable RT?	N/A
N/A	Landing Length (in)	N/A	N/A	DWS Provided?	N/A
N/A	Landing Width (in)	N/A	N/A	DWS Contrast?	N/A
N/A	Landing Slope (%)	N/A	N/A	DWS Length (in)	N/A
N/A	Landing X Slope (%)	N/A	N/A	DWS Full Width?	N/A
N/A	Landing Curb? (Y/N)	N/A	N/A	DWS Offset (in)	N/A
N/A	Shared Landing?	N/A			
N/A	Gutter Ponding?	N/A	N/A	Gutter Slope (%)	N/A
N/A	Gutter Lip Ht (in)	N/A	N/A	Gutter X Slope (%)	N/A
N/A	Painted X Walk1?	No	N/A	Painted X Walk2?	N/A
	X Walk 1 Direction	To E		X Walk 2 Direction	N/A
N/A	X Walk 1 Width (in)	N/A	N/A	X Walk 2 Width (in)	N/A
	X Walk 1 Slope (%)	1.8		X Walk 2 Slope (%)	N/A
	X Walk 1 X Slope (%)	0.6		X Walk 2 X Slope (%)	N/A

Remove & Replace Entire Ramp.

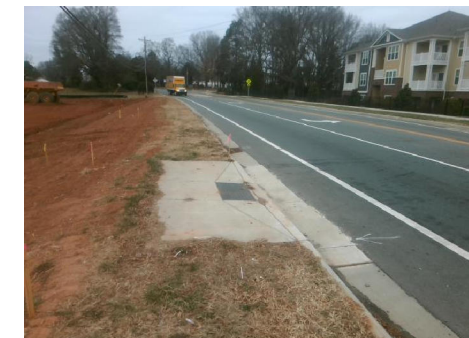
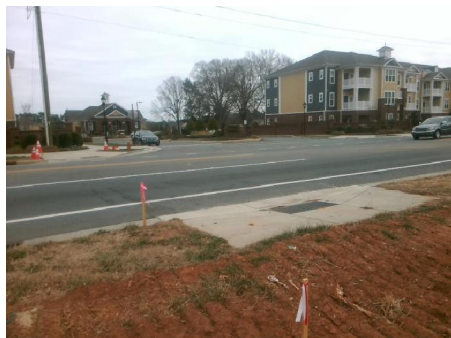
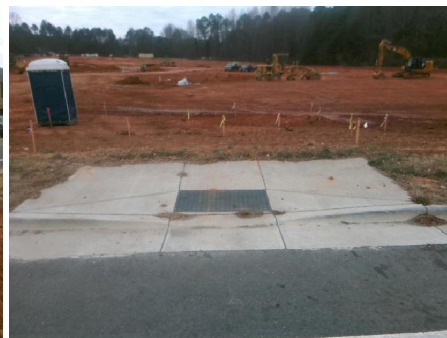
N/A	Ramp inside XWalk1?	N/A	N/A	Ramp inside XWalk2?	N/A
	Road Slope (%)	N/A	N/A	Clear Space?	N/A
	Road X Slope (%)	N/A	N/A	Clear Space to XWalk (in)	N/A
N/A	Any Obstructions?	N/A	N/A	Storm Grate/Utility Hazard?	N/A
	Obstruction Type			Storm Grate/Utility Type	
		N/A			N/A
			Yes	Surface Condition? (G/P)	Good
