Access Compliance Report

Public Rights-of-Way

(Curb Ramps)

Intersection ID: 3655	Main Street: SHENINGTON_PL	Cross Street: TREYBURN_DR	Location: NW
ADA ID: D0D5E5D2F2B5	Ramp Type: Perp	Initial Pass/Fail: Fail	Overall Compliance: No
			Severity Score: 13.75

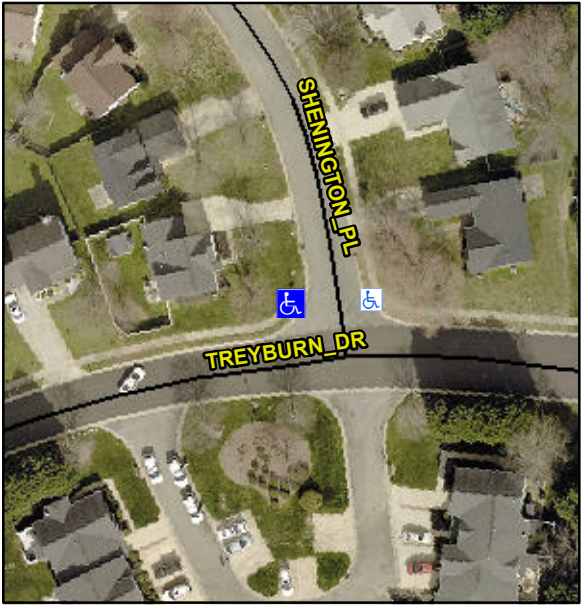
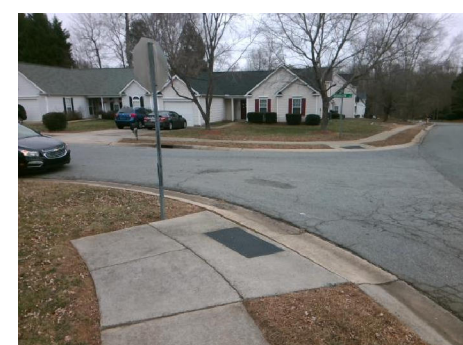
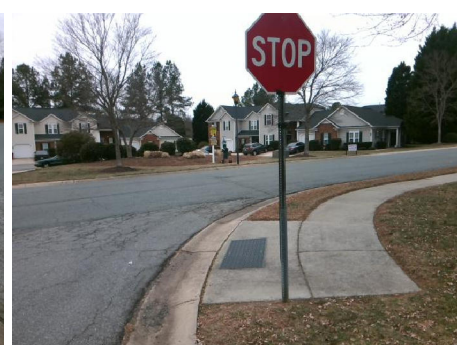
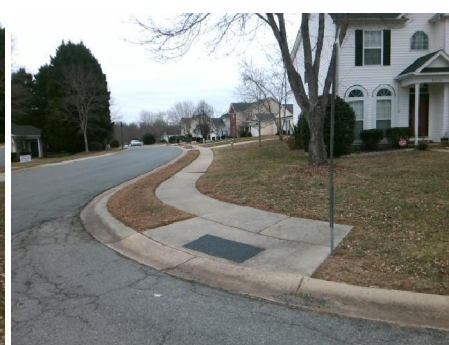
Possible Solutions:		Compliance	Description	Data
	Remove & Replace Entire Ramp.		No	Ramp Length (in)	48.0
			Yes	Ramp Width (in)	48.0
			N/A	Flare Type LT	N/A
			N/A	Flare Slope LT (%)	N/A
			N/A	Flare Traversable LT?	N/A
			N/A	Landing Length (in)	N/A
			N/A	Landing Width (in)	N/A
			N/A	Landing Slope (%)	N/A
			N/A	Landing X Slope (%)	N/A
<p>Surveyor Notes:</p> <p>N/A</p> <p>PROW/ADA:</p> <p>Not Found, R304.2.2, R304.5.3</p>			N/A	Flare Type RT	N/A
			N/A	Flare Slope RT (%)	N/A
			N/A	Flare Traversable RT?	N/A
			N/A	DWS Provided?	N/A
			N/A	DWS Contrast?	N/A
			N/A	DWS Length (in)	N/A
			N/A	DWS Full Width?	N/A
			N/A	DWS Offset (in)	N/A
			N/A	Gutter Ponding?	N/A
			N/A	Gutter Lip Ht (in)	0.5
<p>Street 1 Name</p> <p>Stop Condition-Street 2</p> <p>Street 2 Name</p> <p>Stop Condition-Street 1</p>			No	Painted X Walk1?	No

To E	X Walk 2 Direction	N/A
			N/A	X Walk 2 Width (in)	N/A
			1.7	X Walk 2 Slope (%)	N/A
			0.5	X Walk 2 X Slope (%)	N/A
			N/A	Ramp inside XWalk1?	N/A
			N/A	Ramp inside XWalk2?	N/A
			N/A	Clear Space?	N/A
			N/A	Clear Space to XWalk (in)	N/A
			N/A	Storm Grate/Utility Hazard?	N/A
<p>Total Cost:</p> <p>\$ 1850.00</p>			N/A	Storm Grate/Utility Type	N/A
			N/A	Surface Condition? (G/P)	Good
