Access Compliance Report

Public Rights-of-Way (Curb Ramps)

Intersection ID: 5088	Main Street: GLENWATER_DR	Cross Street: MOUNTAINWATER_DR	Location:	E
ADA ID: D0DB664C03F8	Ramp Type: PerpDiag	Initial Pass/Fail: Fail	Overall Compliance: No	Severity Score: 50
Codes/Mitigation Info/Possible Solution		Field Measurements/Component Compliance

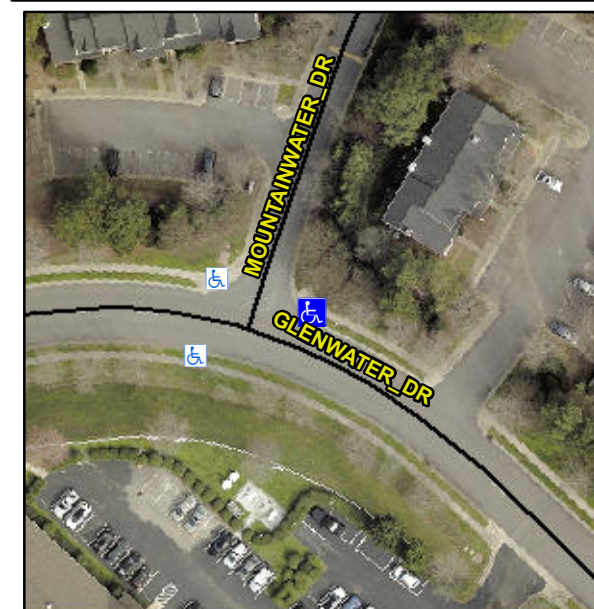
Not Found, R304.2.2, R304.5.3

Compliance	Description	Data	Compliance	Description	Data
N/A	Ramp Length (in)	96.0	No	Ramp Slope (%)	12.8
Yes	Ramp Width (in)	58.0	No	Ramp XSlope (%)	12.4
N/A	Flare Type LT	N/A	N/A	Flare Type RT	N/A
N/A	Flare Slope LT (%)	N/A	N/A	Flare Slope RT (%)	N/A
N/A	Flare Traversable LT?	N/A	N/A	Flare Traversable RT?	N/A
N/A	Landing Length (in)	N/A	N/A	DWS Provided?	N/A
N/A	Landing Width (in)	N/A	N/A	DWS Contrast?	N/A
N/A	Landing Slope (%)	N/A	N/A	DWS Length (in)	N/A
N/A	Landing X Slope (%)	N/A	N/A	DWS Full Width?	N/A
N/A	Landing Curb? (Y/N)	N/A	N/A	DWS Offset (in)	N/A
N/A	Shared Landing?	N/A			
N/A	Gutter Ponding?	N/A	N/A	Gutter Slope (%)	N/A
N/A	Gutter Lip Ht (in)	1.5	N/A	Gutter X Slope (%)	N/A
N/A	Painted X Walk1?	No	N/A	Painted X Walk2?	No
	X Walk 1 Direction	To NW		X Walk 2 Direction	To SW
N/A	X Walk 1 Width (in)	N/A	N/A	X Walk 2 Width (in)	N/A
	X Walk 1 Slope (%)	3.5		X Walk 2 Slope (%)	6.4
	X Walk 1 X Slope (%)	5.8		X Walk 2 X Slope (%)	3.6

N/A	Ramp inside XWalk1?	N/A	N/A	Ramp inside XWalk2?	N/A
	Road Slope (%)	6.5	N/A	Clear Space?	N/A
	Road X Slope (%)	3.6	N/A	Clear Space to XWalk (in)	N/A
N/A	Any Obstructions?	N/A	N/A	Storm Grate/Utility Hazard?	N/A
	Obstruction Type			Storm Grate/Utility Type	
		N/A			N/A
			Yes	Surface Condition? (G/P)	Good

Possible Solutions:

Remove & Replace Curb Ramp With Two New Directional Ramps or Equivalent.
