Access Compliance Report

Public Rights-of-Way

(Curb Ramps)

Intersection ID: 20760	Main Street: SHARON_RD	Cross Street: SHARON_VIEW_RD	Location: NE
ADA ID: D0E6B6414C3C	Ramp Type: MedianPerp	Initial Pass/Fail: Fail	Overall Compliance: No
Severity Score: 33.75			
Codes/Mitigation Info/Possible Solution		Field Measurements/Component Compliance

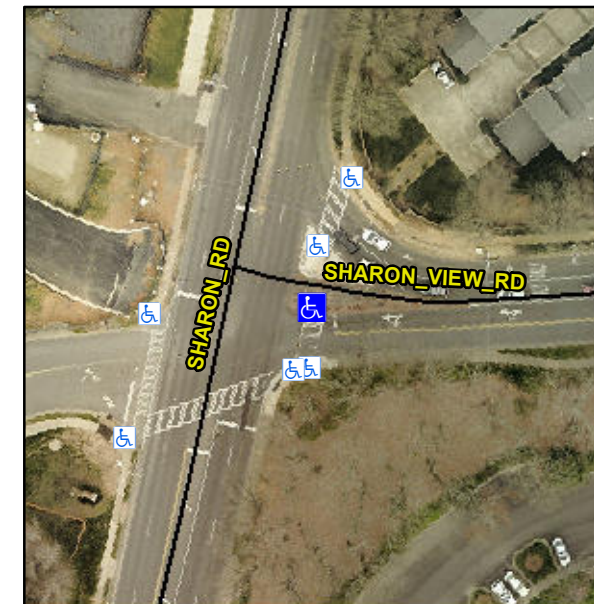
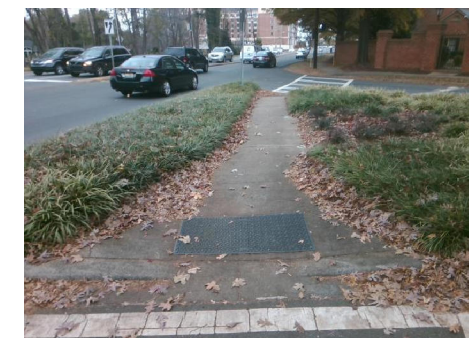
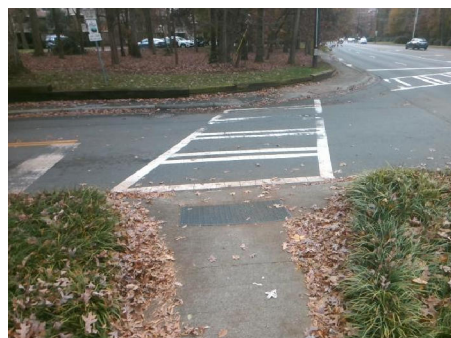
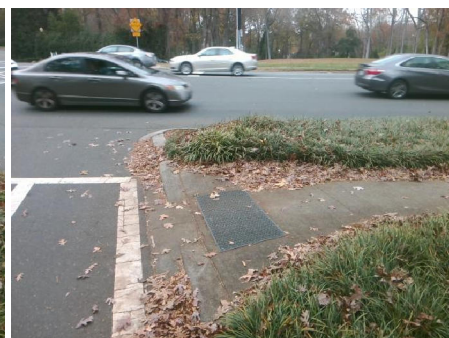
Not Found, R304.5.1, R304.2.2, R304.5.3

Compliance	Description	Data	Compliance	Description	Data
N/A	Ramp Length (in)	60.0	No	Ramp Slope (%)	10.2
No	Ramp Width (in)	40.0	No	Ramp XSlope (%)	5.1
N/A	Flare Type LT	N/A	N/A	Flare Type RT	N/A
N/A	Flare Slope LT (%)	N/A	N/A	Flare Slope RT (%)	N/A
N/A	Flare Traversable LT?	N/A	N/A	Flare Traversable RT?	N/A
N/A	Landing Length (in)	N/A	N/A	DWS Provided?	N/A
N/A	Landing Width (in)	N/A	N/A	DWS Contrast?	N/A
N/A	Landing Slope (%)	N/A	N/A	DWS Length (in)	N/A
N/A	Landing X Slope (%)	N/A	N/A	DWS Full Width?	N/A
N/A	Landing Curb? (Y/N)	N/A	N/A	DWS Offset (in)	N/A
N/A	Shared Landing?	N/A			
N/A	Gutter Ponding?	N/A	N/A	Gutter Slope (%)	N/A
N/A	Gutter Lip Ht (in)	N/A	N/A	Gutter X Slope (%)	N/A
N/A	Painted X Walk1?	Yes	N/A	Painted X Walk2?	N/A
	X Walk 1 Direction	To SW		X Walk 2 Direction	N/A
N/A	X Walk 1 Width (in)	108.0	N/A	X Walk 2 Width (in)	N/A
	X Walk 1 Slope (%)	2.1		X Walk 2 Slope (%)	N/A
	X Walk 1 X Slope (%)	1.0		X Walk 2 X Slope (%)	N/A

N/A	Ramp inside XWalk1?	Yes	N/A	Ramp inside XWalk2?	N/A
	Road Slope (%)	N/A	N/A	Clear Space?	N/A
	Road X Slope (%)	N/A	N/A	Clear Space to XWalk (in)	N/A
N/A	Any Obstructions?	N/A	N/A	Storm Grate/Utility Hazard?	N/A
	Obstruction Type			Storm Grate/Utility Type	
		N/A			N/A
		Yes		Surface Condition? (G/P)	Good

Remove & Replace Entire Ramp.
