# Access Compliance Report

## Public Rights-of-Way

### (Curb Ramps)

Intersection ID: 54218	Main Street: GOLF_LINKS_DR	Cross Street: SANDY_ROCK_PL	Location: SW
ADA ID: D0F332D447EF	Ramp Type: Directional1	Initial Pass/Fail: Fail	Overall Compliance: No
			Severity Score: 13.75

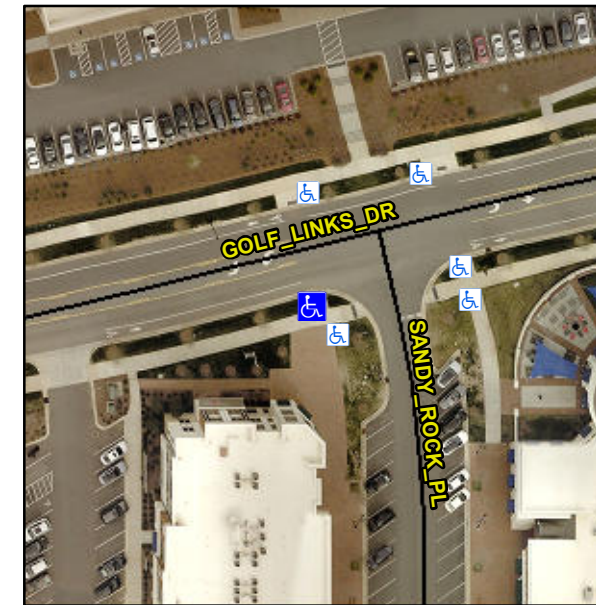
Compliance	Description	Data	Compliance	Description	Data
N/A	Ramp Length (in)	92.0	N/A	Grade Break?	N/A
Yes	Ramp Width (in)	96.0	N/A	Grade Break Slope (%)	0.0
No	Ramp Slope (%)	8.6	N/A	Grade Break XSlope (%)	0.0
No	Ramp XSlope (%)	2.4			
N/A	Flare Type LT	N/A	N/A	Flare Type RT	N/A
N/A	Flare Slope LT (%)	N/A	N/A	Flare Slope RT (%)	0.0
N/A	Flare Traversable LT?	N/A	N/A	Flare Traversable RT?	N/A
N/A	Landing Length (in)	0.0	N/A	DWS Provided?	N/A
N/A	Landing Width (in)	0.0	N/A	DWS Contrast?	N/A
N/A	Landing Slope (%)	0.0	N/A	DWS Length (in)	N/A
N/A	Landing X Slope (%)	0.0	N/A	DWS Full Width?	N/A
N/A	Landing Curb? (Y/N)	N/A	N/A	DWS Offset LT (in)	N/A
N/A	Shared Landing?	N/A	N/A	DWS Offset RT (in)	N/A
N/A	Gutter Ponding?	0.0	N/A	Gutter Slope (%)	N/A
N/A	Gutter Lip Ht (in)	0.0	N/A	Gutter X Slope (%)	N/A
N/A	Painted X Walk1?	No		Road Slope (%)	3.9
	X Walk 1 Direction	To N		Road X Slope (%)	0.6
	X Walk 1 Width (in)	N/A		Clear Space?	N/A

X Walk 1 Slope (%)	3.9	N/A	Clear Space to XWalk (in)	N/A
	X Walk 1 X Slope (%)	0.6	N/A	Storm Grate/Utility Hazard?	N/A
N/A	Ramp inside XWalk1?	N/A		Storm Grate/Utility Type	
N/A	Any Obstructions?	N/A			N/A
	Obstruction Type		Yes	Surface Condition? (G/P)	Good
			N/A	Curb Slope (%)	7.6

Possible Solutions:

**Remove & Replace Entire Ramp.**

**R304.2.2, R304.5.3**

Total Cost: \$ 1600.00
