# Access Compliance Report

## Public Rights-of-Way

### (Curb Ramps)

| ADA ID: D0F9B339253F | Ramp Type: BlendTrans2 | Initial Pass/Fail: Fail | Overall Compliance: No |

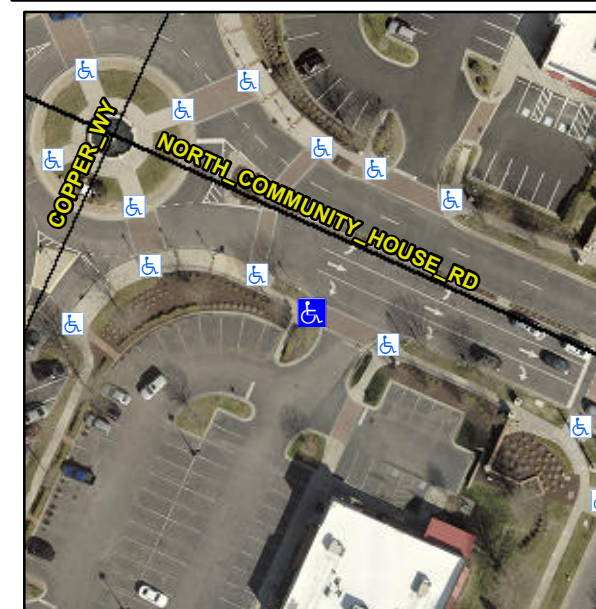
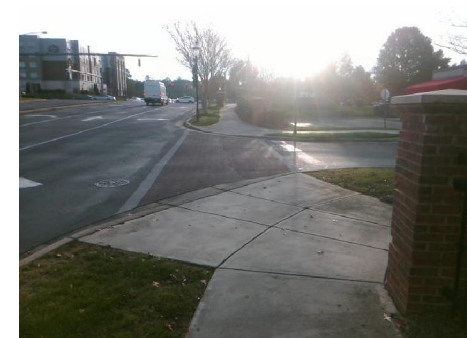
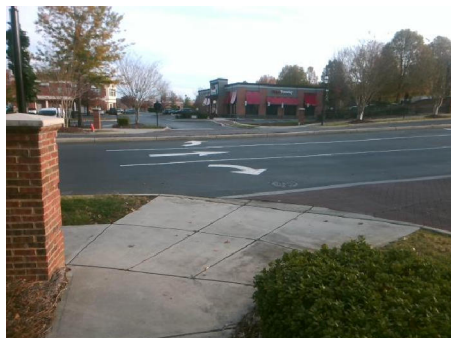
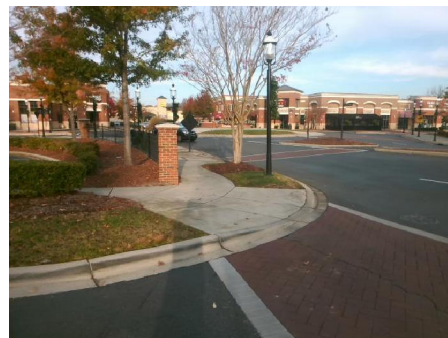
**MEDIAN ACROSS NORTH COMMUNITY HOUSE RD**

**R304.5.1, R304.5.3**

| Compliance | Description | Data | Compliance | Description | Data |
|---|---|---|---|---|---|
| No | Ramp Width (in) | 28.5 | No | BlendTrans XSlope (%) | 4.6 |

**Remove & Replace Curb Ramp With Two New Directional Ramps or Equivalent.**
