Access Compliance Report

Public Rights-of-Way

(Curb Ramps)

Intersection ID: 27487	Main Street: MEADOW_RUN_LN	Cross Street: OAKTHORPE_DR	Location: NE
ADA ID: D12050DCEE0C	Ramp Type: PerpDiag	Initial Pass/Fail: Fail	Overall Compliance: No
Severity Score: 10			
Codes/Mitigation Info/Possible Solution		Field Measurements/Component Compliance

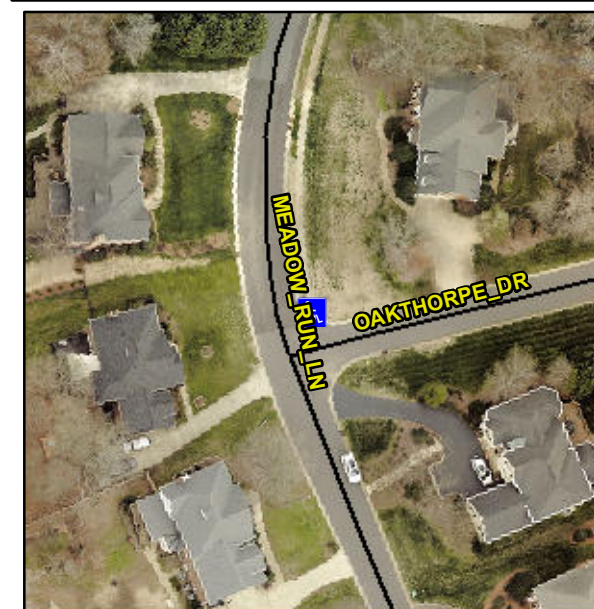
Compliance	Description	Data	Compliance	Description	Data
N/A	Ramp Length (in)	29.0	Yes	Ramp Slope (%)	6.8
No	Ramp Width (in)	46.5	No	Ramp XSlope (%)	2.8
N/A	Flare Type LT	N/A	N/A	Flare Type RT	N/A
N/A	Flare Slope LT (%)	N/A	N/A	Flare Slope RT (%)	N/A
N/A	Flare Traversable LT?	N/A	N/A	Flare Traversable RT?	N/A
N/A	Landing Length (in)	N/A	N/A	DWS Provided?	N/A
N/A	Landing Width (in)	N/A	N/A	DWS Contrast?	N/A
N/A	Landing Slope (%)	N/A	N/A	DWS Length (in)	N/A
N/A	Landing X Slope (%)	N/A	N/A	DWS Full Width?	N/A
N/A	Landing Curb? (Y/N)	N/A	N/A	DWS Offset (in)	N/A
N/A	Shared Landing?	N/A			
N/A	Gutter Ponding?	N/A	N/A	Gutter Slope (%)	N/A
N/A	Gutter Lip Ht (in)	N/A	N/A	Gutter X Slope (%)	N/A
N/A	Painted X Walk1?	No	N/A	Painted X Walk2?	No
	X Walk 1 Direction	To W		X Walk 2 Direction	To SE
N/A	X Walk 1 Width (in)	N/A	N/A	X Walk 2 Width (in)	N/A
	X Walk 1 Slope (%)	1.8		X Walk 2 Slope (%)	5.4
	X Walk 1 X Slope (%)	4.8		X Walk 2 X Slope (%)	3.8

N/A	Ramp inside XWalk1?	N/A	N/A	Ramp inside XWalk2?	N/A
	Road Slope (%)	5.1	N/A	Clear Space?	N/A
	Road X Slope (%)	2.0	N/A	Clear Space to XWalk (in)	N/A
N/A	Any Obstructions?	N/A	N/A	Storm Grate/Utility Hazard?	N/A
	Obstruction Type			Storm Grate/Utility Type	
		N/A			N/A
			Yes	Surface Condition? (G/P)	Good

Remove & Replace Curb Ramp With Two New Directional Ramps or Equivalent.

R304.5.1, R304.5.3
