# Access Compliance Report

## Public Rights-of-Way

### (Curb Ramps)

Intersection ID: 19925	Main Street: SARDIS_RD	Cross Street: PROVIDENCE_RD	Location: E
ADA ID: D1284B39371D	Ramp Type: PerpDiag	Initial Pass/Fail: Fail	Overall Compliance: No
			Severity Score: 21.25

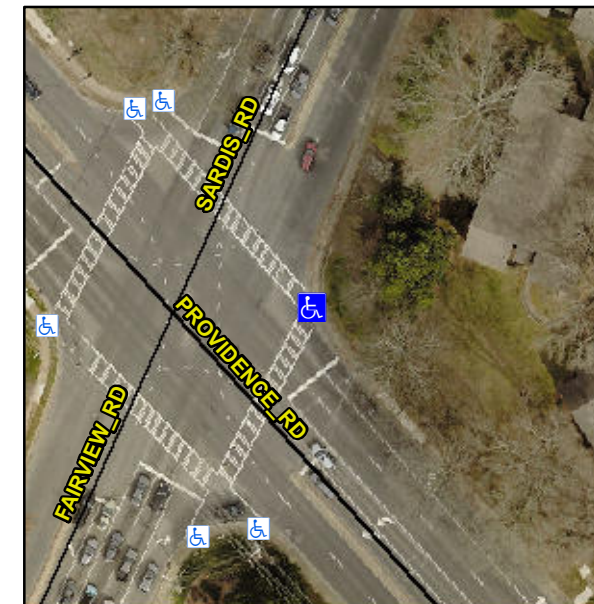
**Not Found, R304.5.1, R304.2.2**

Compliance	Description	Data	Compliance	Description	Data
N/A	Ramp Length (in)	56.0	No	Ramp Slope (%)	9.6
No	Ramp Width (in)	39.0	Yes	Ramp XSlope (%)	0.8
N/A	Flare Type LT	N/A	N/A	Flare Type RT	N/A
N/A	Flare Slope LT (%)	N/A	N/A	Flare Slope RT (%)	N/A
N/A	Flare Traversable LT?	N/A	N/A	Flare Traversable RT?	N/A
N/A	Landing Length (in)	N/A	N/A	DWS Provided?	N/A
N/A	Landing Width (in)	N/A	N/A	DWS Contrast?	N/A
N/A	Landing Slope (%)	N/A	N/A	DWS Length (in)	N/A
N/A	Landing X Slope (%)	N/A	N/A	DWS Full Width?	N/A
N/A	Landing Curb? (Y/N)	N/A	N/A	DWS Offset (in)	N/A
N/A	Shared Landing?	N/A			
N/A	Gutter Ponding?	N/A	N/A	Gutter Slope (%)	N/A
N/A	Gutter Lip Ht (in)	N/A	N/A	Gutter X Slope (%)	N/A
N/A	Painted X Walk1?	Yes	N/A	Painted X Walk2?	Yes
	X Walk 1 Direction	To NW		X Walk 2 Direction	To SW
N/A	X Walk 1 Width (in)	95.0	N/A	X Walk 2 Width (in)	106.0
	X Walk 1 Slope (%)	1.7		X Walk 2 Slope (%)	3.8
	X Walk 1 X Slope (%)	2.3		X Walk 2 X Slope (%)	1.8

N/A	Ramp inside XWalk1?	Yes	N/A	Ramp inside XWalk2?	Yes
	Road Slope (%)	1.0	N/A	Clear Space?	N/A
	Road X Slope (%)	4.5	N/A	Clear Space to XWalk (in)	N/A
N/A	Any Obstructions?	N/A	N/A	Storm Grate/Utility Hazard?	N/A
	Obstruction Type			Storm Grate/Utility Type	
		N/A			N/A
			Yes	Surface Condition? (G/P)	Good

**Remove & Replace Curb Ramp With Two New Directional Ramps or Equivalent.**

Total Cost: \$ 3200.00
