# Access Compliance Report

## Public Rights-of-Way

### (Curb Ramps)

| Intersection ID: 7500 | Main Street: OWEN_BV | Cross Street: MCGILL_ST | Location: SW |

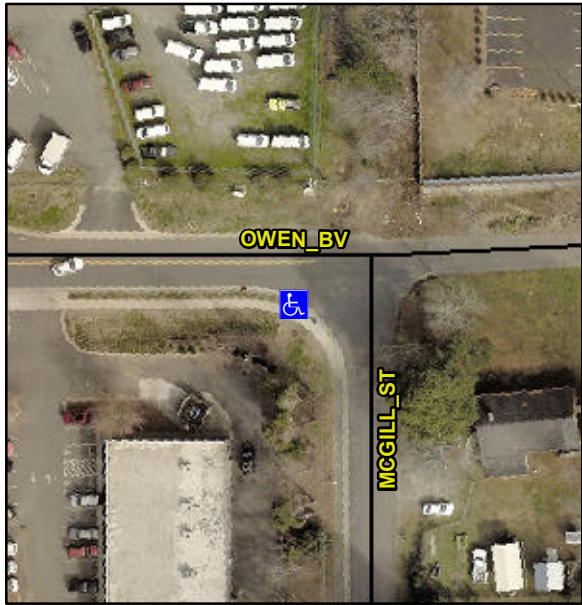
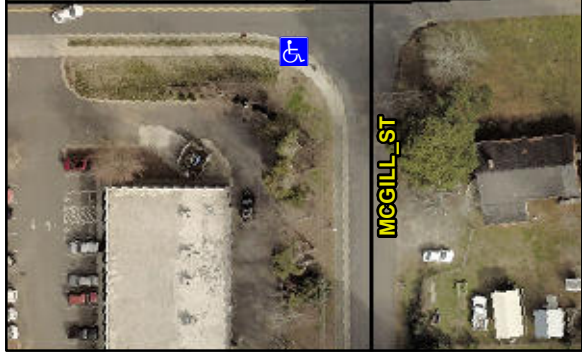
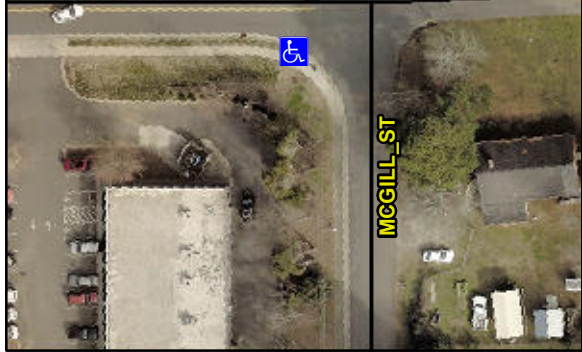
| ADA ID: D12933D14CD4 | Ramp Type: PerpDiag | Initial Pass/Fail: Fail | Overall Compliance: No |

| | <b>R304.2.2</b> | | | | | | |
| Stop Condition-Street 2 | <b>StopSign</b> | N/A | Ramp Length (in) | 24.0 | No | Ramp Slope (%) | 11.1 |

| | <b>Remove &amp; Replace Curb Ramp With Two New Directional Ramps or Equivalent.</b> | | | | | | |
