Access Compliance Report

Public Rights-of-Way

(Curb Ramps)

Intersection ID: 10040761	Main Street: W_TYVOLA_RD	Cross Street: N/A	Location: SE
ADA ID: D13369427668	Ramp Type: PerpDiag	Initial Pass/Fail: Fail	Overall Compliance: No
Severity Score: 58.75			
Codes/Mitigation Info/Possible Solution		Field Measurements/Component Compliance

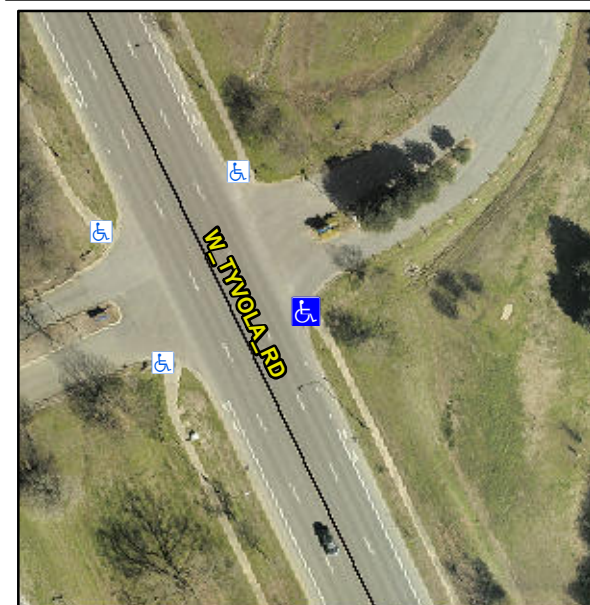
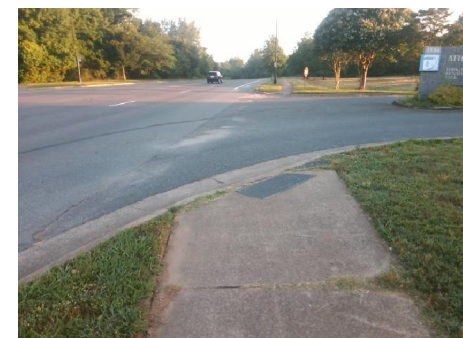
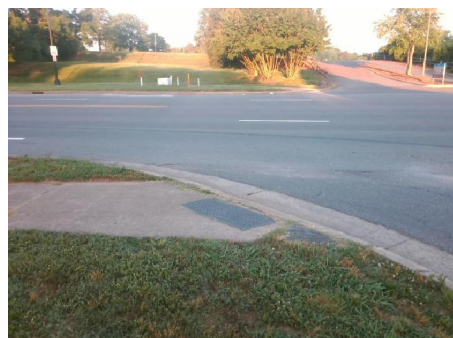
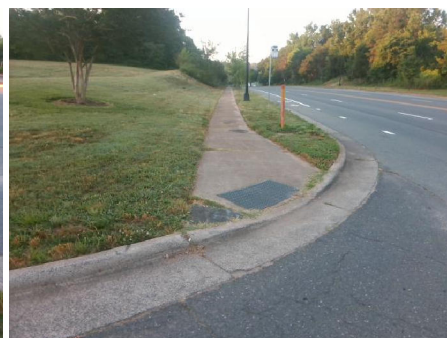
Compliance	Description	Data	Compliance	Description	Data
N/A	Ramp Length (in)	68.0	No	Ramp Slope (%)	12.3
No	Ramp Width (in)	45.0	No	Ramp XSlope (%)	7.8
N/A	Flare Type LT	N/A	N/A	Flare Type RT	N/A
N/A	Flare Slope LT (%)	N/A	N/A	Flare Slope RT (%)	N/A
N/A	Flare Traversable LT?	N/A	N/A	Flare Traversable RT?	N/A
N/A	Landing Length (in)	N/A	N/A	DWS Provided?	N/A
N/A	Landing Width (in)	N/A	N/A	DWS Contrast?	N/A
N/A	Landing Slope (%)	N/A	N/A	DWS Length (in)	N/A
N/A	Landing X Slope (%)	N/A	N/A	DWS Full Width?	N/A
N/A	Landing Curb? (Y/N)	N/A	N/A	DWS Offset (in)	N/A
N/A	Shared Landing?	N/A			
N/A	Gutter Ponding?	N/A	N/A	Gutter Slope (%)	N/A
N/A	Gutter Lip Ht (in)	N/A	N/A	Gutter X Slope (%)	N/A
N/A	Painted X Walk1?	No	N/A	Painted X Walk2?	No
	X Walk 1 Direction	To N		X Walk 2 Direction	To W
N/A	X Walk 1 Width (in)	N/A	N/A	X Walk 2 Width (in)	N/A
	X Walk 1 Slope (%)	0.6		X Walk 2 Slope (%)	2.3
	X Walk 1 X Slope (%)	5.8		X Walk 2 X Slope (%)	0.6

N/A	Ramp inside XWalk1?	N/A	N/A	Ramp inside XWalk2?	N/A
	Road Slope (%)	4.6	N/A	Clear Space?	N/A
	Road X Slope (%)	2.8	N/A	Clear Space to XWalk (in)	N/A
N/A	Any Obstructions?	N/A	N/A	Storm Grate/Utility Hazard?	N/A
	Obstruction Type			Storm Grate/Utility Type	
		N/A			N/A
			Yes	Surface Condition? (G/P)	Good

Remove & Replace Curb Ramp With Two New Directional Ramps or Equivalent.
