Access Compliance Report

Public Rights-of-Way

(Curb Ramps)

Intersection ID: 23137	Main Street: MORROWICK_RD	Cross Street: WHITNEY_HILL_RD	Location: NW
ADA ID: D14C560B8BDA	Ramp Type: PerpDiag	Initial Pass/Fail: Fail	Overall Compliance: No
Severity Score: 37.5			
Codes/Mitigation Info/Possible Solution		Field Measurements/Component Compliance

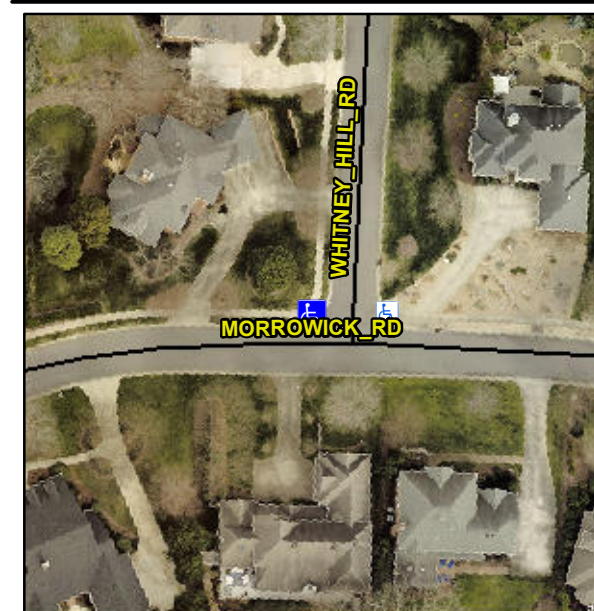
Not Found, R304.2.2, R304.5.3

Compliance	Description	Data	Compliance	Description	Data
N/A	Ramp Length (in)	50.0	No	Ramp Slope (%)	8.5
Yes	Ramp Width (in)	48.0	No	Ramp XSlope (%)	9.7
N/A	Flare Type LT	N/A	N/A	Flare Type RT	N/A
N/A	Flare Slope LT (%)	N/A	N/A	Flare Slope RT (%)	N/A
N/A	Flare Traversable LT?	N/A	N/A	Flare Traversable RT?	N/A
N/A	Landing Length (in)	N/A	N/A	DWS Provided?	N/A
N/A	Landing Width (in)	N/A	N/A	DWS Contrast?	N/A
N/A	Landing Slope (%)	N/A	N/A	DWS Length (in)	N/A
N/A	Landing X Slope (%)	N/A	N/A	DWS Full Width?	N/A
N/A	Landing Curb? (Y/N)	N/A	N/A	DWS Offset (in)	N/A
N/A	Shared Landing?	N/A			
N/A	Gutter Ponding?	N/A	N/A	Gutter Slope (%)	N/A
N/A	Gutter Lip Ht (in)	N/A	N/A	Gutter X Slope (%)	N/A
N/A	Painted X Walk1?	No	N/A	Painted X Walk2?	No
	X Walk 1 Direction	To S		X Walk 2 Direction	To E
N/A	X Walk 1 Width (in)	N/A	N/A	X Walk 2 Width (in)	N/A
	X Walk 1 Slope (%)	2.1		X Walk 2 Slope (%)	9.0
	X Walk 1 X Slope (%)	9.7		X Walk 2 X Slope (%)	4.3

N/A	Ramp inside XWalk1?	N/A	N/A	Ramp inside XWalk2?	N/A
	Road Slope (%)	9.8	N/A	Clear Space?	N/A
	Road X Slope (%)	8.8	N/A	Clear Space to XWalk (in)	N/A
N/A	Any Obstructions?	N/A	N/A	Storm Grate/Utility Hazard?	N/A
	Obstruction Type			Storm Grate/Utility Type	
		N/A			N/A
		Yes		Surface Condition? (G/P)	Good

Remove & Replace Curb Ramp With Two New Directional Ramps or Equivalent.
