# Access Compliance Report

## Public Rights-of-Way

### (Curb Ramps)

Intersection ID: 30378	Main Street: VERNEDALE_GLEN_DR	Cross Street: WILORA_LAKE_RD	Location: NW
ADA ID: D15B877F344A	Ramp Type: Perp	Initial Pass/Fail: Fail	Overall Compliance: No
Severity Score: 13.75			
Codes/Mitigation Info/Possible Solution		Field Measurements/Component Compliance

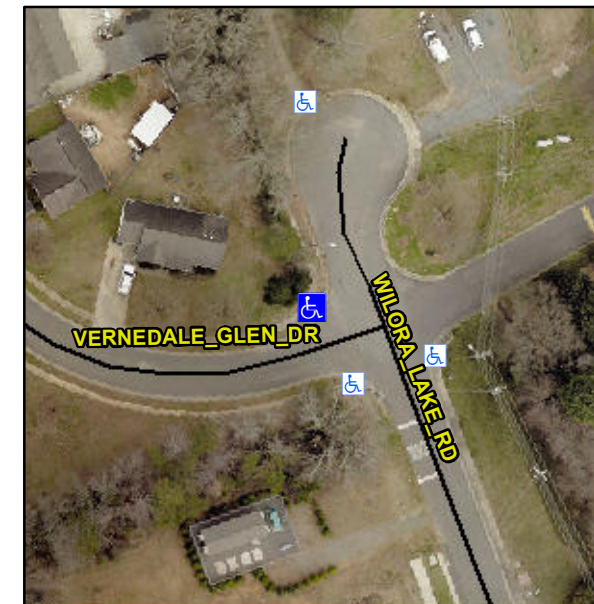
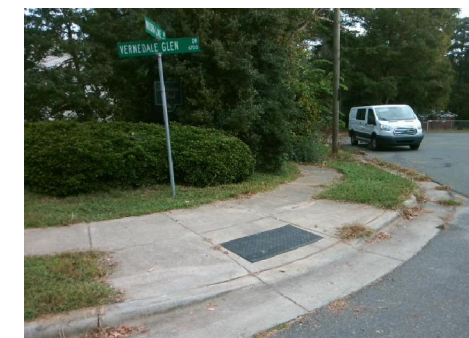
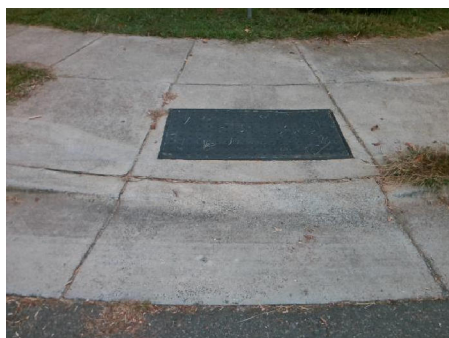
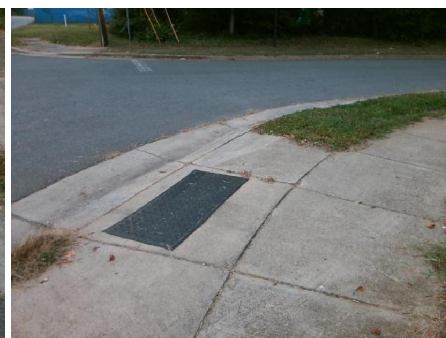
**Not Found, R304.2.2, R304.5.3**

Compliance	Description	Data	Compliance	Description	Data
N/A	Ramp Length (in)	48.0	No	Ramp Slope (%)	8.9
Yes	Ramp Width (in)	49.5	No	Ramp XSlope (%)	4.3
N/A	Flare Type LT	N/A	N/A	Flare Type RT	N/A
N/A	Flare Slope LT (%)	N/A	N/A	Flare Slope RT (%)	N/A
N/A	Flare Traversable LT?	N/A	N/A	Flare Traversable RT?	N/A
N/A	Landing Length (in)	N/A	N/A	DWS Provided?	N/A
N/A	Landing Width (in)	N/A	N/A	DWS Contrast?	N/A
N/A	Landing Slope (%)	N/A	N/A	DWS Length (in)	N/A
N/A	Landing X Slope (%)	N/A	N/A	DWS Full Width?	N/A
N/A	Landing Curb? (Y/N)	N/A	N/A	DWS Offset (in)	N/A
N/A	Shared Landing?	N/A			
N/A	Gutter Ponding?	N/A	N/A	Gutter Slope (%)	N/A
N/A	Gutter Lip Ht (in)	N/A	N/A	Gutter X Slope (%)	N/A
N/A	Painted X Walk1?	No	N/A	Painted X Walk2?	N/A
	X Walk 1 Direction	To S		X Walk 2 Direction	N/A
N/A	X Walk 1 Width (in)	N/A	N/A	X Walk 2 Width (in)	N/A
	X Walk 1 Slope (%)	0.9		X Walk 2 Slope (%)	N/A
	X Walk 1 X Slope (%)	1.5		X Walk 2 X Slope (%)	N/A

N/A	Ramp inside XWalk1?	N/A	N/A	Ramp inside XWalk2?	N/A
	Road Slope (%)	N/A	N/A	Clear Space?	N/A
	Road X Slope (%)	N/A	N/A	Clear Space to XWalk (in)	N/A
N/A	Any Obstructions?	N/A	N/A	Storm Grate/Utility Hazard?	N/A
	Obstruction Type			Storm Grate/Utility Type	
		N/A			N/A
			Yes	Surface Condition? (G/P)	Good

**Remove & Replace Entire Ramp.**

Total Cost: \$ 1850.00
