## Access Compliance Report Public Rights-of-Way (Curb Ramps)

Intersection ID: 10025869Main Street:ELEVATION\_POINT\_DRCross Street:N/ALocation:NADA ID: D15F936A6B76Ramp Type:PerpInitial Pass/Fail:PassOverall Compliance:NoSeverity Score:0.25

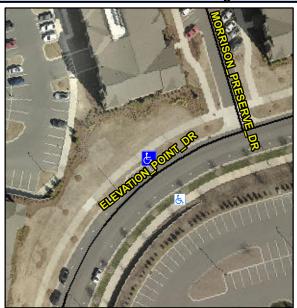
TO A STATE OF THE PARTY OF THE	400
Street 1 Name	<b>ELEVATION POINT DR</b>
Stop Condition-Street 2	None
Street 2 Name	N/A
Stop Condition-Street 1	N/A

N/A	Ramp Length (in)	42.0	Yes	Ramp Slope (%)	5.2
Yes	Ramp Width (in)	58.0	No	Ramp XSlope (%)	4.2
Yes	Flare Type LCurbed_NoWalkSurface		Yes	Flare Type RT	N/A
Yes	Flare Slope LT (%)	N/A	N/A	Flare Slope RT (%)	N/A
N/A	Flare Traversable LT?	No	N/A	Flare Traversable RT?	No
Yes	Landing Length (in)	100.0	Yes	DWS Provided?	Yes
Yes	Landing Width (in)	69.5	Yes	DWS Contrast?	Yes
No	Landing Slope (%)	2.3	Yes	DWS Length (in)	24.0
Yes	Landing X Slope (%)	1.6	Yes	DWS Full Width?	Yes
N/A	Landing Curb? (Y/N)	Yes	Yes	DWS Offset (in)	0.0
N/A	Shared Landing?	No			
Yes	Gutter Ponding?	No	Yes	Gutter Slope (%)	1.7
Yes	Gutter Lip Ht (in)	0.0	Yes	Gutter X Slope (%)	1.3
N/A	Painted X Walk1?	No	N/A	Painted X Walk2?	N/A
	X Walk 1 Direction	To SE		X Walk 2 Direction	N/A
N/A	X Walk 1 Width (in)	N/A	N/A	X Walk 2 Width (in)	N/A
	X Walk 1 Slope (%)	1.2		X Walk 2 Slope (%)	N/A
	X Walk 1 X Slope (%)	1.7		X Walk 2 X Slope (%)	N/A
N/A	Ramp inside XWalk1?	N/A	N/A	Ramp inside XWalk2?	N/A

Road Slope (%)	N/A	N/A	Clear Space?	Yes
	Road X Slope (%)	N/A	N/A	Clear Space to XWalk (in)	N/A
Yes	Any Obstructions?	No	Yes	Storm Grate/Utility Hazard?	No
	Obstruction Type			Storm Grate/Utility Type	
		N/A			N/A
			Yes	Surface Condition? (G/P)	Good

Possible Solutions:					
Remove & Replace Entire Ramp.					
•					
Surveyor Notes:					
N/A					
PROW/ADA:					
Not Found, R304.5.3, R304.2.2-Perp,					
R304.3.2-Para
