# Access Compliance Report

## Public Rights-of-Way

### (Curb Ramps)

Intersection ID: 10036062	Main Street: RIVERGATE_PY	Cross Street: N/A	Location:	NE
ADA ID: D15FA6D894C6	Ramp Type: BlendTrans2	Initial Pass/Fail: Pass	Overall Compliance: No	Severity Score: 2.5
Codes/Mitigation Info/Possible Solution		Field Measurements/Component Compliance

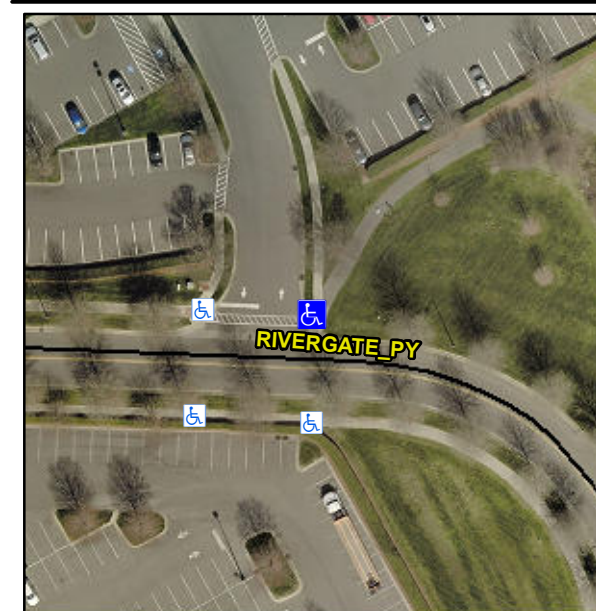
Compliance	Description	Data	Compliance	Description	Data
N/A	Ramp Length (in)	128.0	Yes	BlendTrans Slope (%)	2.5
Yes	Ramp Width (in)	61.0	Yes	BlendTrans XSlope (%)	1.4
N/A	Flare Type LT	Sloped	N/A	Flare Type RT	Sloped
N/A	Flare Slope LT (%)	N/A	N/A	Flare Slope RT (%)	N/A
N/A	Flare Traversable LT?	No	N/A	Flare Traversable RT?	No
N/A	Landing Length (in)	N/A	Yes	DWS Provided?	Yes
N/A	Landing Width (in)	N/A	Yes	DWS Contrast?	Yes
N/A	Landing Slope (%)	N/A	Yes	DWS Length (in)	24.0
N/A	Landing X Slope (%)	N/A	No	DWS Full Width?	No
N/A	Landing Curb? (Y/N)	No	No	DWS Offset (in)	5.0
N/A	Shared Landing?	No			
Yes	Gutter Ponding?	No	Yes	Gutter Slope (%)	2.4
Yes	Gutter Lip Ht (in)	0.0	Yes	Gutter X Slope (%)	1.1
N/A	Painted X Walk1?	Yes	N/A	Painted X Walk2?	No
	X Walk 1 Direction	To W		X Walk 2 Direction	To S
	X Walk 1 Width (in)	49.0		X Walk 2 Width (in)	N/A
	X Walk 1 Slope (%)	1.9		X Walk 2 Slope (%)	0.8
	X Walk 1 X Slope (%)	1.8		X Walk 2 X Slope (%)	4.3

Yes	Ramp inside XWalk1?	Yes	N/A	Ramp inside XWalk2?	N/A
	Road Slope (%)	0.5		Clear Space?	Yes
	Road X Slope (%)	1.4	N/A	Clear Space to XWalk (in)	N/A
Yes	Any Obstructions?	No	Yes	Storm Grate/Utility Hazard?	No
	Obstruction Type			Storm Grate/Utility Type	
		N/A			N/A
			Yes	Surface Condition? (G/P)	Good
			No	Curb Slope (%)	18.8

Possible Solutions:

**Remove & Replace Curb Ramp With Two New Directional Ramps or Equivalent.**

**Not Found, R305.1.4, R305.2**

Total Cost: \$ 3200.00
