Access Compliance Report

Public Rights-of-Way

(Curb Ramps)

Intersection ID: 14147	Main Street: CHERRY_ST	Cross Street: LUTHER_ST	Location: SE
ADA ID: D1777FE70117	Ramp Type: PerpDiag	Initial Pass/Fail: Fail	Overall Compliance: No
			Severity Score: 18.75

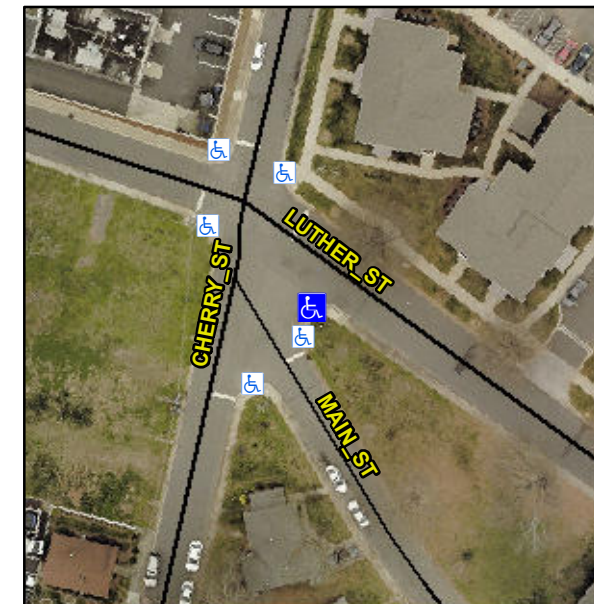
Compliance	Description	Data	Compliance	Description	Data
N/A	Ramp Length (in)	60.0	Yes	Ramp Slope (%)	6.3
No	Ramp Width (in)	33.5	No	Ramp XSlope (%)	3.2
N/A	Flare Type LT	N/A	N/A	Flare Type RT	N/A
N/A	Flare Slope LT (%)	N/A	N/A	Flare Slope RT (%)	N/A
N/A	Flare Traversable LT?	N/A	N/A	Flare Traversable RT?	N/A
N/A	Landing Length (in)	N/A	N/A	DWS Provided?	N/A
N/A	Landing Width (in)	N/A	N/A	DWS Contrast?	N/A
N/A	Landing Slope (%)	N/A	N/A	DWS Length (in)	N/A
N/A	Landing X Slope (%)	N/A	N/A	DWS Full Width?	N/A
N/A	Landing Curb? (Y/N)	N/A	N/A	DWS Offset (in)	N/A
N/A	Shared Landing?	N/A			
N/A	Gutter Ponding?	N/A	N/A	Gutter Slope (%)	N/A
N/A	Gutter Lip Ht (in)	N/A	N/A	Gutter X Slope (%)	N/A
N/A	Painted X Walk1?	No	N/A	Painted X Walk2?	No
	X Walk 1 Direction	To SW		X Walk 2 Direction	To N
N/A	X Walk 1 Width (in)	N/A	N/A	X Walk 2 Width (in)	N/A
	X Walk 1 Slope (%)	3.0		X Walk 2 Slope (%)	1.0
	X Walk 1 X Slope (%)	3.6		X Walk 2 X Slope (%)	3.1

N/A	Ramp inside XWalk1?	N/A	N/A	Ramp inside XWalk2?	N/A
	Road Slope (%)	2.1	N/A	Clear Space?	N/A
	Road X Slope (%)	2.5	N/A	Clear Space to XWalk (in)	N/A
N/A	Any Obstructions?	N/A	N/A	Storm Grate/Utility Hazard?	N/A
	Obstruction Type			Storm Grate/Utility Type	
		N/A			N/A
			Yes	Surface Condition? (G/P)	Good

Remove & Replace Curb Ramp With Two New Directional Ramps or Equivalent.

R304.5.1, R304.5.3
