Access Compliance Report

Public Rights-of-Way

(Curb Ramps)

Intersection ID: 52453	Main Street: PAT_GARRETT_ST	Cross Street: DOUBLE_OAKS_RD	Location: NE
ADA ID: D17A3FD8B9FD	Ramp Type: Perp	Initial Pass/Fail: Fail	Overall Compliance: No
Severity Score: 12.5			
Codes/Mitigation Info/Possible Solution		Field Measurements/Component Compliance

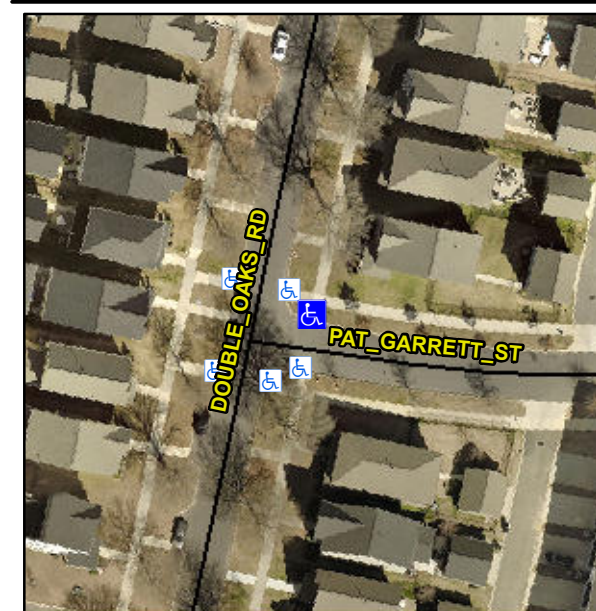
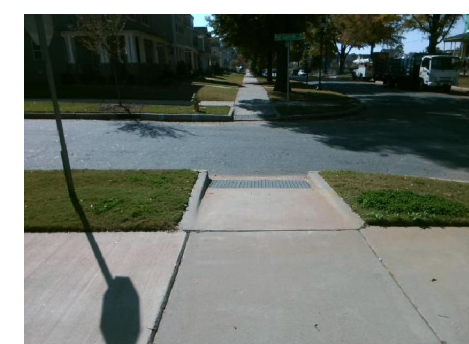
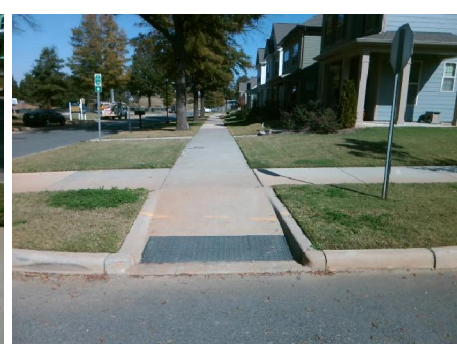
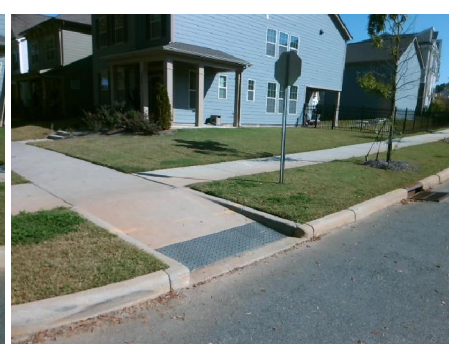
R304.2.2

Compliance	Description	Data	Compliance	Description	Data
N/A	Ramp Length (in)	102.0	No	Ramp Slope (%)	11.3
Yes	Ramp Width (in)	67.0	Yes	Ramp XSlope (%)	1.2
N/A	Flare Type LT	N/A	N/A	Flare Type RT	N/A
N/A	Flare Slope LT (%)	N/A	N/A	Flare Slope RT (%)	N/A
N/A	Flare Traversable LT?	N/A	N/A	Flare Traversable RT?	N/A
N/A	Landing Length (in)	N/A	N/A	DWS Provided?	N/A
N/A	Landing Width (in)	N/A	N/A	DWS Contrast?	N/A
N/A	Landing Slope (%)	N/A	N/A	DWS Length (in)	N/A
N/A	Landing X Slope (%)	N/A	N/A	DWS Full Width?	N/A
N/A	Landing Curb? (Y/N)	N/A	N/A	DWS Offset (in)	N/A
N/A	Shared Landing?	N/A			
N/A	Gutter Ponding?	N/A	N/A	Gutter Slope (%)	N/A
N/A	Gutter Lip Ht (in)	N/A	N/A	Gutter X Slope (%)	N/A
N/A	Painted X Walk1?	No	N/A	Painted X Walk2?	N/A
	X Walk 1 Direction	To S		X Walk 2 Direction	N/A
N/A	X Walk 1 Width (in)	N/A	N/A	X Walk 2 Width (in)	N/A
	X Walk 1 Slope (%)	2.1		X Walk 2 Slope (%)	N/A
	X Walk 1 X Slope (%)	1.8		X Walk 2 X Slope (%)	N/A

N/A	Ramp inside XWalk1?	N/A	N/A	Ramp inside XWalk2?	N/A
	Road Slope (%)	N/A	N/A	Clear Space?	N/A
	Road X Slope (%)	N/A	N/A	Clear Space to XWalk (in)	N/A
N/A	Any Obstructions?	N/A	N/A	Storm Grate/Utility Hazard?	N/A
	Obstruction Type			Storm Grate/Utility Type	
		N/A			N/A
			Yes	Surface Condition? (G/P)	Good

Remove & Replace Entire Ramp.

\$ 1850.00
