Access Compliance Report

Public Rights-of-Way

(Curb Ramps)

Intersection ID: 8276	Main Street: BROOKSHIRE_BV	Cross Street: N LINWOOD_AV	Location: SE
ADA ID: D17E3E8825B5	Ramp Type: Para	Initial Pass/Fail: Fail	Overall Compliance: No
Codes/Mitigation Info/Possible Solution		Field Measurements/Component Compliance	
Severity Score: 13.75

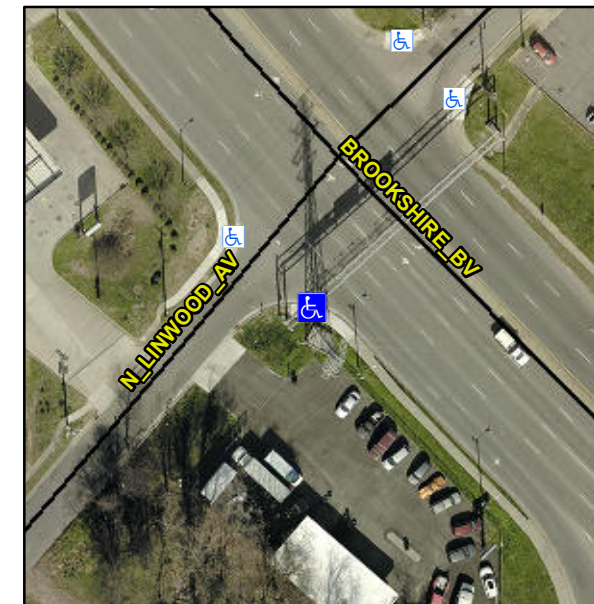
NO RT SW, RT RP < 5%

R304.3.2, R304.5.3

Compliance	Description	Data	Compliance	Description	Data
N/A	Ramp Length LT (in)	42.0	N/A	Ramp Length RT (in)	46.0
Yes	Ramp Width LT (in)	53.0	Yes	Ramp Width RT (in)	53.0
No	Ramp Slope LT (%)	11.9	Yes	Ramp Slope RT (%)	3.1
Yes	Ramp XSlope LT (%)	1.3	No	Ramp XSlope RT (%)	2.9
N/A	Landing Length (in)	N/A	N/A	DWS Provided?	N/A
N/A	Landing Width (in)	N/A	N/A	DWS Contrast?	N/A
N/A	Landing Slope (%)	N/A	N/A	DWS Length (in)	N/A
N/A	Landing X Slope (%)	N/A	N/A	DWS Full Width?	N/A
N/A	Landing Curb? (Y/N)	N/A	N/A	DWS Offset (in)	N/A
N/A	Shared Landing?	N/A			
N/A	Gutter Ponding?	N/A	N/A	Gutter Slope (%)	N/A
N/A	Gutter Lip Ht (in)	N/A	N/A	Gutter X Slope (%)	N/A
N/A	Painted X Walk1?	No	N/A	Painted X Walk2?	N/A
	X Walk 1 Direction	To NW		X Walk 2 Direction	N/A
N/A	X Walk 1 Width (in)	N/A	N/A	X Walk 2 Width (in)	N/A
	X Walk 1 Slope (%)	0.2		X Walk 2 Slope (%)	N/A
	X Walk 1 X Slope (%)	6.8		X Walk 2 X Slope (%)	N/A
N/A	Ramp inside XWalk1?	N/A	N/A	Ramp inside XWalk2?	N/A

Road Slope (%)	N/A	N/A	Clear Space?	N/A
	Road X Slope (%)	N/A	N/A	Clear Space to XWalk (in)	N/A
N/A	Any Obstructions?	N/A	N/A	Storm Grate/Utility Hazard?	N/A
	Obstruction Type			Storm Grate/Utility Type	
		N/A			N/A
			Yes	Surface Condition? (G/P)	Good
			N/A	Curb Slope (%)	13.4

Possible Solutions:

Remove & Replace Entire Ramp.

Total Cost: \$ 1600.00
