# Access Compliance Report

## Public Rights-of-Way

### (Curb Ramps)

| Intersection ID: 11195 | Main Street: DELGANY_DR | Cross Street: GLENVILLE_AV | Location: SE |

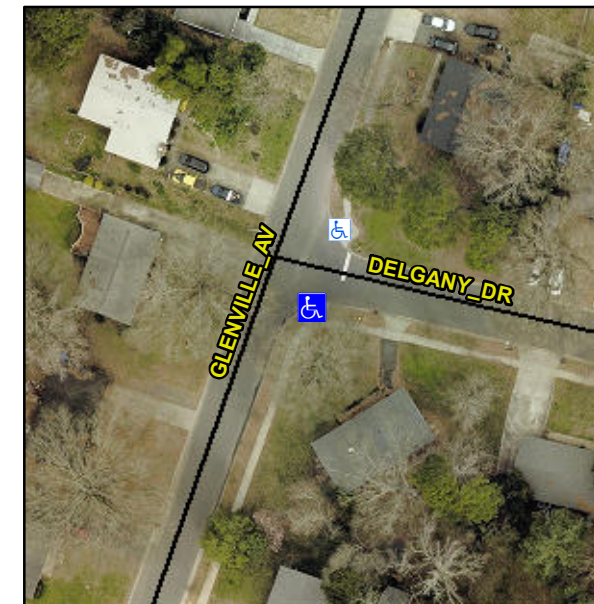
| ADA ID: D1A914773A05 | Ramp Type: BlendTrans1 | Initial Pass/Fail: Fail | Overall Compliance: No |
| | | Severity Score: 10 | |

**Not Found, R304.5.1, R304.5.3**

| Compliance | Description | Data | Compliance | Description | Data |
|---|---|---|---|---|---|
| N/A | Ramp Length (in) | 72.5 | Yes | BlendTrans Slope (%) | 3.3 |
| No | Ramp Width (in) | 47.5 | No | BlendTrans XSlope (%) | 3.0 |
| | | | No | Curb Slope (%) | 13.8 |

**Remove & Replace Curb Ramp With Two New Directional Ramps or Equivalent.**

Total Cost: \$ 3200.00
