Access Compliance Report

Public Rights-of-Way

(Curb Ramps)

Intersection ID: 23079	Main Street: KINGSMEADE_CT	Cross Street: MOORLAND_DR	Location: NE
ADA ID: D1B1B324B69A	Ramp Type: PerpDiag	Initial Pass/Fail: Fail	Overall Compliance: No
Severity Score: 10			
Codes/Mitigation Info/Possible Solution		Field Measurements/Component Compliance

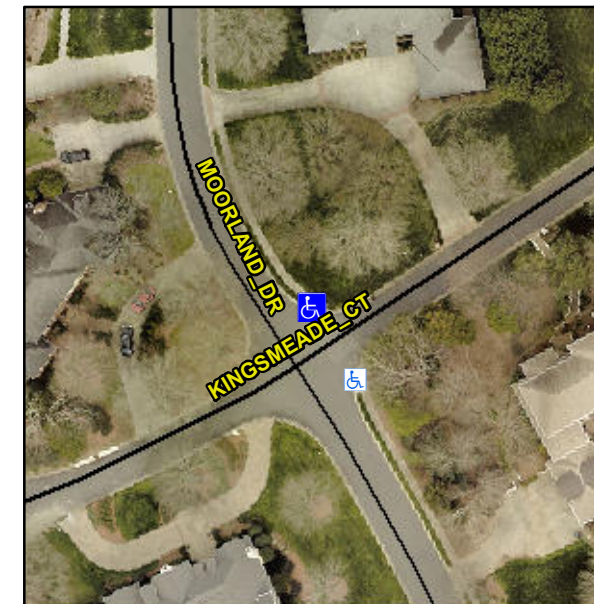
Not Found, R304.5.1, R304.5.3

Compliance	Description	Data	Compliance	Description	Data
N/A	Ramp Length (in)	52.0	Yes	Ramp Slope (%)	5.8
No	Ramp Width (in)	47.0	No	Ramp XSlope (%)	2.7
N/A	Flare Type LT	N/A	N/A	Flare Type RT	N/A
N/A	Flare Slope LT (%)	N/A	N/A	Flare Slope RT (%)	N/A
N/A	Flare Traversable LT?	N/A	N/A	Flare Traversable RT?	N/A
N/A	Landing Length (in)	N/A	N/A	DWS Provided?	N/A
N/A	Landing Width (in)	N/A	N/A	DWS Contrast?	N/A
N/A	Landing Slope (%)	N/A	N/A	DWS Length (in)	N/A
N/A	Landing X Slope (%)	N/A	N/A	DWS Full Width?	N/A
N/A	Landing Curb? (Y/N)	N/A	N/A	DWS Offset (in)	N/A
N/A	Shared Landing?	N/A			
N/A	Gutter Ponding?	N/A	N/A	Gutter Slope (%)	N/A
N/A	Gutter Lip Ht (in)	N/A	N/A	Gutter X Slope (%)	N/A
N/A	Painted X Walk1?	No	N/A	Painted X Walk2?	No
	X Walk 1 Direction	To W		X Walk 2 Direction	To S
N/A	X Walk 1 Width (in)	N/A	N/A	X Walk 2 Width (in)	N/A
	X Walk 1 Slope (%)	0.2		X Walk 2 Slope (%)	2.7
	X Walk 1 X Slope (%)	1.8		X Walk 2 X Slope (%)	1.3

N/A	Ramp inside XWalk1?	N/A	N/A	Ramp inside XWalk2?	N/A
	Road Slope (%)	1.2	N/A	Clear Space?	N/A
	Road X Slope (%)	2.1	N/A	Clear Space to XWalk (in)	N/A
N/A	Any Obstructions?	N/A	N/A	Storm Grate/Utility Hazard?	N/A
	Obstruction Type			Storm Grate/Utility Type	
		N/A			N/A
			Yes	Surface Condition? (G/P)	Good

Possible Solutions:

Remove & Replace Curb Ramp With Two New Directional Ramps or Equivalent.
