Access Compliance Report

Public Rights-of-Way

(Curb Ramps)

Intersection ID: 8503	Main Street: TIMEPLANNER_DR	Cross Street: ATANDO_AV	Location: SW
ADA ID: D1B2B10E6B96	Ramp Type: Perp	Initial Pass/Fail: Fail	Overall Compliance: No
		Severity Score: 25

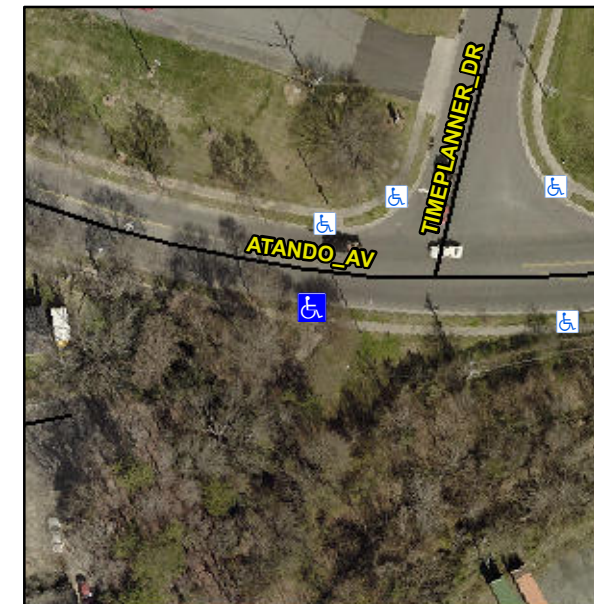
Not Found, R304.2.2

Compliance	Description	Data	Compliance	Description	Data
N/A	Ramp Length (in)	59.0	No	Ramp Slope (%)	12.5
Yes	Ramp Width (in)	48.0	Yes	Ramp XSlope (%)	0.4
N/A	Flare Type LT	N/A	N/A	Flare Type RT	N/A
N/A	Flare Slope LT (%)	N/A	N/A	Flare Slope RT (%)	N/A
N/A	Flare Traversable LT?	N/A	N/A	Flare Traversable RT?	N/A
N/A	Landing Length (in)	N/A	N/A	DWS Provided?	N/A
N/A	Landing Width (in)	N/A	N/A	DWS Contrast?	N/A
N/A	Landing Slope (%)	N/A	N/A	DWS Length (in)	N/A
N/A	Landing X Slope (%)	N/A	N/A	DWS Full Width?	N/A
N/A	Landing Curb? (Y/N)	N/A	N/A	DWS Offset (in)	N/A
N/A	Shared Landing?	N/A			
N/A	Gutter Ponding?	N/A	N/A	Gutter Slope (%)	N/A
N/A	Gutter Lip Ht (in)	N/A	N/A	Gutter X Slope (%)	N/A
N/A	Painted X Walk1?	No	N/A	Painted X Walk2?	N/A
	X Walk 1 Direction	To N		X Walk 2 Direction	N/A
N/A	X Walk 1 Width (in)	N/A	N/A	X Walk 2 Width (in)	N/A
	X Walk 1 Slope (%)	1.0		X Walk 2 Slope (%)	N/A
	X Walk 1 X Slope (%)	1.2		X Walk 2 X Slope (%)	N/A

N/A	Ramp inside XWalk1?	N/A	N/A	Ramp inside XWalk2?	N/A
	Road Slope (%)	N/A	N/A	Clear Space?	N/A
	Road X Slope (%)	N/A	N/A	Clear Space to XWalk (in)	N/A
N/A	Any Obstructions?	N/A	N/A	Storm Grate/Utility Hazard?	N/A
	Obstruction Type			Storm Grate/Utility Type	
		N/A			N/A
			Yes	Surface Condition? (G/P)	Good

Remove & Replace Entire Ramp.

Total Cost: \$ 1850.00
