Access Compliance Report

Public Rights-of-Way

(Curb Ramps)

Intersection ID: N/A	Main Street: ENDAHVEN_LN	Cross Street: N_COMMUNITY_HOUSE_RD	Location: NW
ADA ID: D1C64CB1E1CD	Ramp Type: Perp	Initial Pass/Fail: Fail	Overall Compliance: No
		Severity Score: 22.5

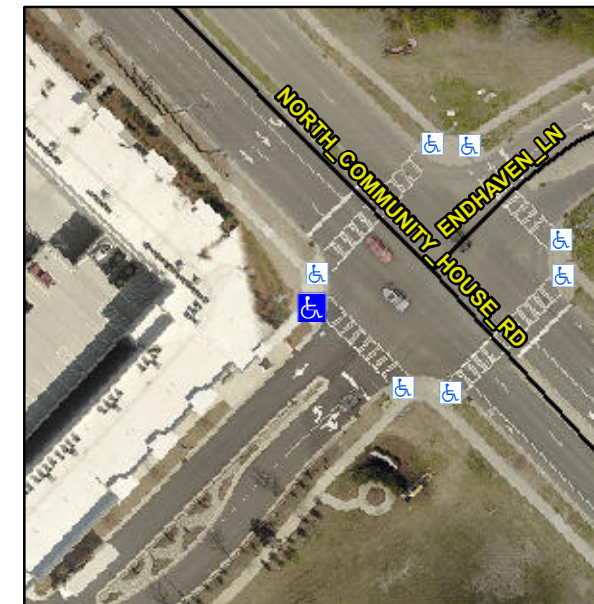
R304.5.1, R304.2.2, R304.5.3

Compliance	Description	Data	Compliance	Description	Data
N/A	Ramp Length (in)	71.5	No	Ramp Slope (%)	9.0
No	Ramp Width (in)	44.0	No	Ramp XSlope (%)	3.8
N/A	Flare Type LT	N/A	N/A	Flare Type RT	N/A
N/A	Flare Slope LT (%)	N/A	N/A	Flare Slope RT (%)	N/A
N/A	Flare Traversable LT?	N/A	N/A	Flare Traversable RT?	N/A
N/A	Landing Length (in)	N/A	N/A	DWS Provided?	N/A
N/A	Landing Width (in)	N/A	N/A	DWS Contrast?	N/A
N/A	Landing Slope (%)	N/A	N/A	DWS Length (in)	N/A
N/A	Landing X Slope (%)	N/A	N/A	DWS Full Width?	N/A
N/A	Landing Curb? (Y/N)	N/A	N/A	DWS Offset (in)	N/A
N/A	Shared Landing?	N/A			
N/A	Gutter Ponding?	N/A	N/A	Gutter Slope (%)	N/A
N/A	Gutter Lip Ht (in)	N/A	N/A	Gutter X Slope (%)	N/A
N/A	Painted X Walk1?	Yes	N/A	Painted X Walk2?	N/A
	X Walk 1 Direction	To SE		X Walk 2 Direction	N/A
N/A	X Walk 1 Width (in)	112.0	N/A	X Walk 2 Width (in)	N/A
	X Walk 1 Slope (%)	0.5		X Walk 2 Slope (%)	N/A
	X Walk 1 X Slope (%)	1.6		X Walk 2 X Slope (%)	N/A

N/A	Ramp inside XWalk1?	No	N/A	Ramp inside XWalk2?	N/A
	Road Slope (%)	N/A	N/A	Clear Space?	N/A
	Road X Slope (%)	N/A	N/A	Clear Space to XWalk (in)	N/A
N/A	Any Obstructions?	N/A	N/A	Storm Grate/Utility Hazard?	N/A
	Obstruction Type			Storm Grate/Utility Type	
		N/A			N/A
			Yes	Surface Condition? (G/P)	Good

**Remove & Replace Entire Ramp.
Restripe Crosswalk.**
