# Access Compliance Report

## Public Rights-of-Way (Curb Ramps)

| Intersection ID: 10034399 | Main Street: PIEDMONT_PARK_DR | Cross Street: AUDUBON_PARK_DR | Location: E |
| ADA ID: D1D6A186F586 | Ramp Type: Directional1 | Initial Pass/Fail: Pass | Overall Compliance: No |

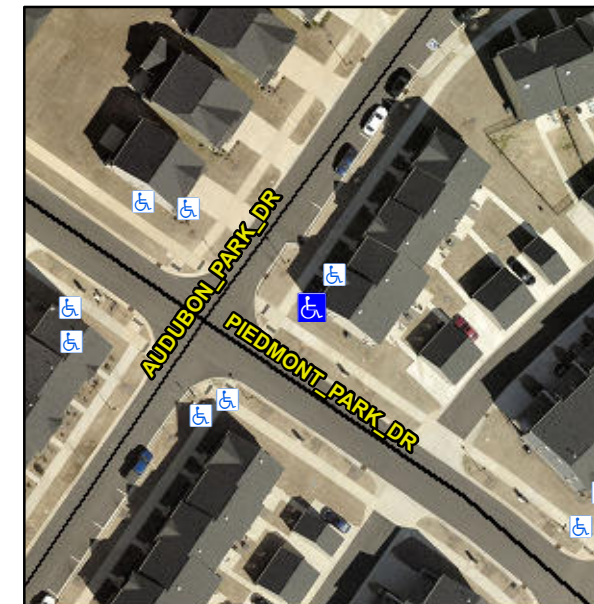
**R305.2**

| Compliance | Description | Data | Compliance | Description | Data |
|---|---|---|---|---|---|
| N/A | Landing Curb? (Y/N) | N/A | No | DWS Offset LT (in) | 13.0 |

**Remove & Replace Detectable  
Warning System.**
