Access Compliance Report

Public Rights-of-Way

(Curb Ramps)

Intersection ID: 4139	Main Street: FOGGY_BANK_LN	Cross Street: PITAL_CT	Location:	E
ADA ID: D1E9E5EB565C	Ramp Type: BlendTrans1	Initial Pass/Fail: Fail	Overall Compliance: No	Severity Score: 33.75
Codes/Mitigation Info/Possible Solution		Field Measurements/Component Compliance

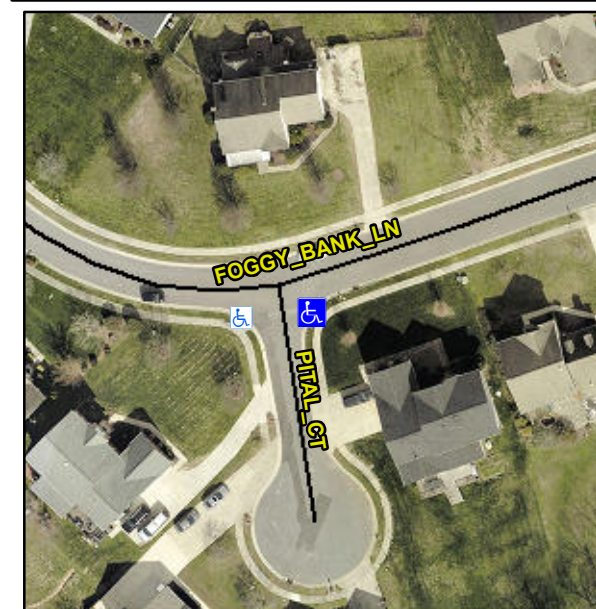
R304.5.1, R304.5.3

Compliance	Description	Data	Compliance	Description	Data
N/A	Ramp Length (in)	47.5	Yes	BlendTrans Slope (%)	4.4
No	Ramp Width (in)	38.0	No	BlendTrans XSlope (%)	9.8
N/A	Flare Type LT	N/A	N/A	Flare Type RT	N/A
N/A	Flare Slope LT (%)	N/A	N/A	Flare Slope RT (%)	N/A
N/A	Flare Traversable LT?	N/A	N/A	Flare Traversable RT?	N/A
N/A	Landing Length (in)	N/A	N/A	DWS Provided?	N/A
N/A	Landing Width (in)	N/A	N/A	DWS Contrast?	N/A
N/A	Landing Slope (%)	N/A	N/A	DWS Length (in)	N/A
N/A	Landing X Slope (%)	N/A	N/A	DWS Full Width?	N/A
N/A	Landing Curb? (Y/N)	N/A	N/A	DWS Offset (in)	N/A
N/A	Shared Landing?	N/A			
N/A	Gutter Ponding?	N/A	N/A	Gutter Slope (%)	N/A
N/A	Gutter Lip Ht (in)	N/A	N/A	Gutter X Slope (%)	N/A
N/A	Painted X Walk1?	No	N/A	Painted X Walk2?	N/A
	X Walk 1 Direction	To W		X Walk 2 Direction	N/A
	X Walk 1 Width (in)	N/A		X Walk 2 Width (in)	N/A
	X Walk 1 Slope (%)	5.7		X Walk 2 Slope (%)	N/A
	X Walk 1 X Slope (%)	4.2		X Walk 2 X Slope (%)	N/A

N/A	Ramp inside XWalk1?	N/A	N/A	Ramp inside XWalk2?	N/A
	Road Slope (%)	4.2		Clear Space?	N/A
	Road X Slope (%)	5.7	N/A	Clear Space to XWalk (in)	N/A
N/A	Any Obstructions?	N/A	N/A	Storm Grate/Utility Hazard?	N/A
	Obstruction Type			Storm Grate/Utility Type	
		N/A			N/A
			Yes	Surface Condition? (G/P)	Good
			N/A	Curb Slope (%)	2.2

Remove & Replace Curb Ramp With Two New Directional Ramps or Equivalent.
