# Access Compliance Report

## Public Rights-of-Way

### (Curb Ramps)

| Intersection ID: 17274 | Main Street: MONROE_RD | Cross Street: VISTA_DR | Location: W |

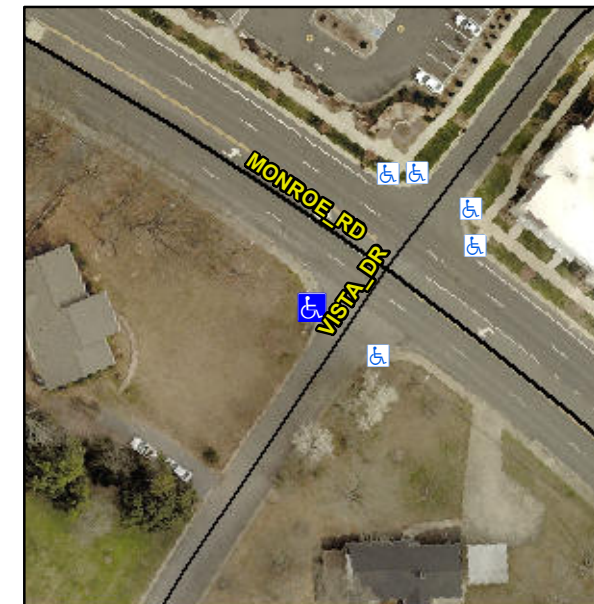
| ADA ID: D1F12CFB05CA | Ramp Type: PerpDiag | Initial Pass/Fail: Pass | Overall Compliance: No |
| Severity Score: 4 | | | |

**Not Found, R304.2.1, R304.2.2-Perp, R304.3.2-Para, R305.2, R304.5.3**

| Compliance | Description | Data | Compliance | Description | Data |
|---|---|---|---|---|---|
| No | Landing Length (in) | 30.0 | Yes | DWS Provided? | Yes |
| No | Landing Width (in) | 46.0 | Yes | DWS Contrast? | Yes |
| No | Landing Slope (%) | 2.4 | Yes | DWS Length (in) | 25.0 |
| N/A | Landing Curb? (Y/N) | No | No | DWS Offset (in) | 3.0 |
| Yes | Gutter Lip Ht (in) | 0.0 | No | Gutter X Slope (%) | 3.2 |

**Remove & Replace Curb Ramp With Two New Directional Ramps or Equivalent. Remove & Replace Gutter.**

Total Cost: \$ 3950.00
