# Access Compliance Report

## Public Rights-of-Way

### (Curb Ramps)

Intersection ID: 25357	Main Street: RAINTREE_LN	Cross Street: WILLOW_POINT_DR	Location: NE
ADA ID: D1F262FF18DF	Ramp Type: Perp	Initial Pass/Fail: Fail	Overall Compliance: No
		Severity Score: 1.25

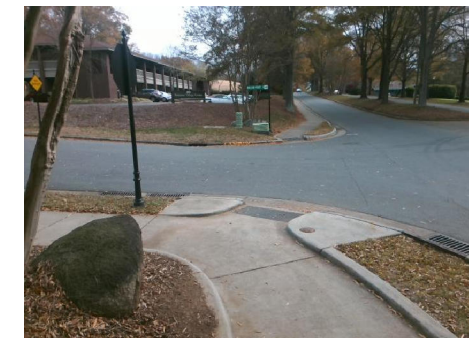
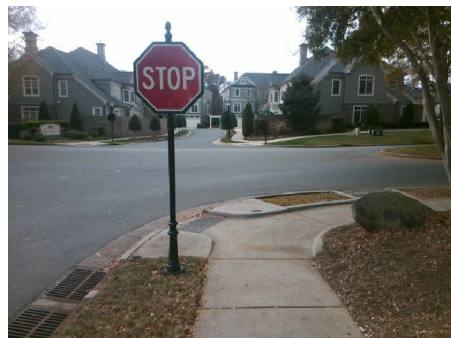
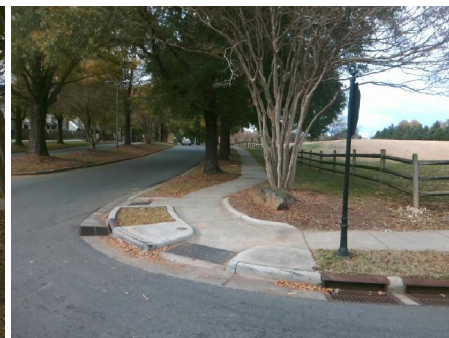
**Not Found, R304.5.3**

Compliance	Description	Data	Compliance	Description	Data
N/A	Ramp Length (in)	60.0	Yes	Ramp Slope (%)	7.3
Yes	Ramp Width (in)	51.0	No	Ramp XSlope (%)	2.7
N/A	Flare Type LT	N/A	N/A	Flare Type RT	N/A
N/A	Flare Slope LT (%)	N/A	N/A	Flare Slope RT (%)	N/A
N/A	Flare Traversable LT?	N/A	N/A	Flare Traversable RT?	N/A
N/A	Landing Length (in)	N/A	N/A	DWS Provided?	N/A
N/A	Landing Width (in)	N/A	N/A	DWS Contrast?	N/A
N/A	Landing Slope (%)	N/A	N/A	DWS Length (in)	N/A
N/A	Landing X Slope (%)	N/A	N/A	DWS Full Width?	N/A
N/A	Landing Curb? (Y/N)	N/A	N/A	DWS Offset (in)	N/A
N/A	Shared Landing?	N/A			
N/A	Gutter Ponding?	N/A	N/A	Gutter Slope (%)	N/A
N/A	Gutter Lip Ht (in)	N/A	N/A	Gutter X Slope (%)	N/A
N/A	Painted X Walk1?	No	N/A	Painted X Walk2?	N/A
	X Walk 1 Direction	To SE		X Walk 2 Direction	N/A
N/A	X Walk 1 Width (in)	N/A	N/A	X Walk 2 Width (in)	N/A
	X Walk 1 Slope (%)	1.1		X Walk 2 Slope (%)	N/A
	X Walk 1 X Slope (%)	2.3		X Walk 2 X Slope (%)	N/A

N/A	Ramp inside XWalk1?	N/A	N/A	Ramp inside XWalk2?	N/A
	Road Slope (%)	N/A	N/A	Clear Space?	N/A
	Road X Slope (%)	N/A	N/A	Clear Space to XWalk (in)	N/A
N/A	Any Obstructions?	N/A	N/A	Storm Grate/Utility Hazard?	N/A
	Obstruction Type			Storm Grate/Utility Type	
		N/A			N/A
			Yes	Surface Condition? (G/P)	Good

**Remove & Replace Entire Ramp.**
