Access Compliance Report

Public Rights-of-Way

(Curb Ramps)

Intersection ID: 46184	Main Street: GLOXINIA_RD	Cross Street: NEEDLEPOINT_RD	Location: SE
ADA ID: D1F457E620C1	Ramp Type: PerpDiag	Initial Pass/Fail: Fail	Overall Compliance: No
Severity Score: 8.75			
Codes/Mitigation Info/Possible Solution		Field Measurements/Component Compliance

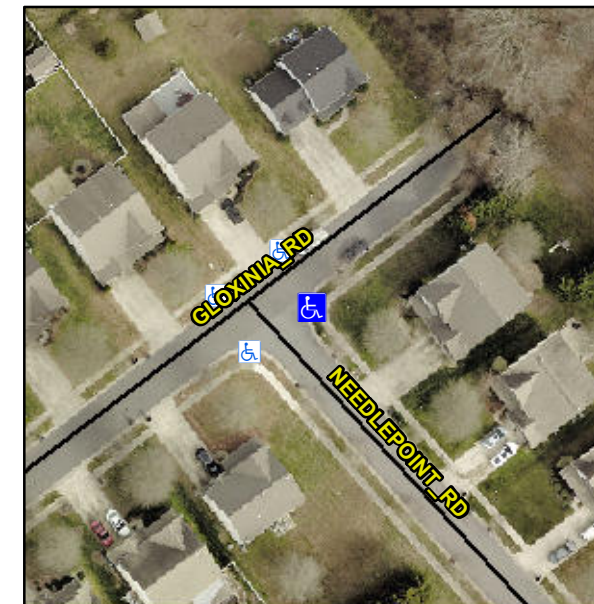
Not Found, R304.5.1

Compliance	Description	Data	Compliance	Description	Data
N/A	Ramp Length (in)	60.5	Yes	Ramp Slope (%)	5.6
No	Ramp Width (in)	47.5	Yes	Ramp XSlope (%)	1.2
N/A	Flare Type LT	N/A	N/A	Flare Type RT	N/A
N/A	Flare Slope LT (%)	N/A	N/A	Flare Slope RT (%)	N/A
N/A	Flare Traversable LT?	N/A	N/A	Flare Traversable RT?	N/A
N/A	Landing Length (in)	N/A	N/A	DWS Provided?	N/A
N/A	Landing Width (in)	N/A	N/A	DWS Contrast?	N/A
N/A	Landing Slope (%)	N/A	N/A	DWS Length (in)	N/A
N/A	Landing X Slope (%)	N/A	N/A	DWS Full Width?	N/A
N/A	Landing Curb? (Y/N)	N/A	N/A	DWS Offset (in)	N/A
N/A	Shared Landing?	N/A			
N/A	Gutter Ponding?	N/A	N/A	Gutter Slope (%)	N/A
N/A	Gutter Lip Ht (in)	N/A	N/A	Gutter X Slope (%)	N/A
N/A	Painted X Walk1?	No	N/A	Painted X Walk2?	No
	X Walk 1 Direction	To N		X Walk 2 Direction	To W
N/A	X Walk 1 Width (in)	N/A	N/A	X Walk 2 Width (in)	N/A
	X Walk 1 Slope (%)	2.5		X Walk 2 Slope (%)	2.3
	X Walk 1 X Slope (%)	2.0		X Walk 2 X Slope (%)	0.4

N/A	Ramp inside XWalk1?	N/A	N/A	Ramp inside XWalk2?	N/A
	Road Slope (%)	1.1	N/A	Clear Space?	N/A
	Road X Slope (%)	1.2	N/A	Clear Space to XWalk (in)	N/A
N/A	Any Obstructions?	N/A	N/A	Storm Grate/Utility Hazard?	N/A
	Obstruction Type			Storm Grate/Utility Type	
		N/A			N/A
			Yes	Surface Condition? (G/P)	Good

Possible Solutions:

Remove & Replace Curb Ramp With Two New Directional Ramps or Equivalent.
