# Access Compliance Report

## Public Rights-of-Way

### (Curb Ramps)

Intersection ID: 10041631	Main Street: WHITEHALL_PARK_DR	Cross Street: N/A	Location: E
ADA ID: D1F55077CE2C	Ramp Type: PerpDiag	Initial Pass/Fail: Fail	Overall Compliance: No
Severity Score: 22.5			
Codes/Mitigation Info/Possible Solution		Field Measurements/Component Compliance

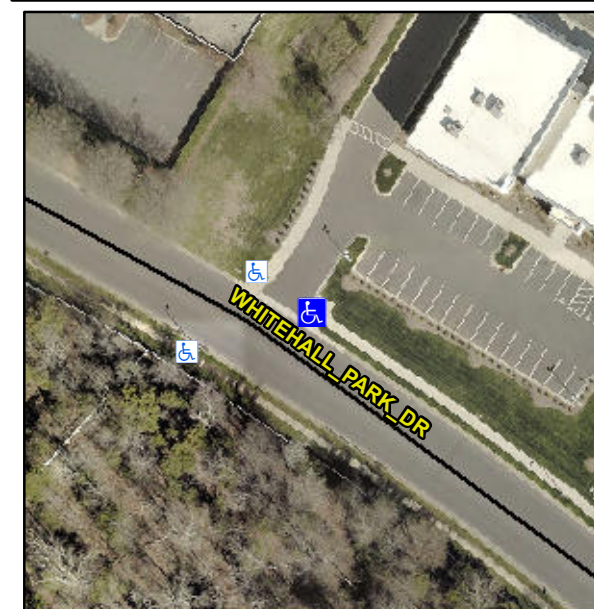
Compliance	Description	Data	Compliance	Description	Data
N/A	Ramp Length (in)	60.0	No	Ramp Slope (%)	8.6
No	Ramp Width (in)	46.0	No	Ramp XSlope (%)	3.2
N/A	Flare Type LT	N/A	N/A	Flare Type RT	N/A
N/A	Flare Slope LT (%)	N/A	N/A	Flare Slope RT (%)	N/A
N/A	Flare Traversable LT?	N/A	N/A	Flare Traversable RT?	N/A
N/A	Landing Length (in)	N/A	N/A	DWS Provided?	N/A
N/A	Landing Width (in)	N/A	N/A	DWS Contrast?	N/A
N/A	Landing Slope (%)	N/A	N/A	DWS Length (in)	N/A
N/A	Landing X Slope (%)	N/A	N/A	DWS Full Width?	N/A
N/A	Landing Curb? (Y/N)	N/A	N/A	DWS Offset (in)	N/A
N/A	Shared Landing?	N/A			
N/A	Gutter Ponding?	N/A	N/A	Gutter Slope (%)	N/A
N/A	Gutter Lip Ht (in)	N/A	N/A	Gutter X Slope (%)	N/A
N/A	Painted X Walk1?	No	N/A	Painted X Walk2?	No
	X Walk 1 Direction	To NW		X Walk 2 Direction	To SW
N/A	X Walk 1 Width (in)	N/A	N/A	X Walk 2 Width (in)	N/A
	X Walk 1 Slope (%)	1.5		X Walk 2 Slope (%)	1.8
	X Walk 1 X Slope (%)	3.5		X Walk 2 X Slope (%)	0.7

N/A	Ramp inside XWalk1?	N/A	N/A	Ramp inside XWalk2?	N/A
	Road Slope (%)	2.0	N/A	Clear Space?	N/A
	Road X Slope (%)	2.0	N/A	Clear Space to XWalk (in)	N/A
N/A	Any Obstructions?	N/A	N/A	Storm Grate/Utility Hazard?	N/A
	Obstruction Type			Storm Grate/Utility Type	
		N/A			N/A
			Yes	Surface Condition? (G/P)	Good

**Remove & Replace Curb Ramp With Two New Directional Ramps or Equivalent.**

**R304.5.1, R304.2.2, R304.5.3**
