Access Compliance Report

Public Rights-of-Way

(Curb Ramps)

Intersection ID: 10032513	Main Street: N_CASWELL_RD	Cross Street: N/A	Location: W
ADA ID: D1F7D7450BEF	Ramp Type: Directional1	Initial Pass/Fail: Fail	Overall Compliance: No
Severity Score: 12.5			
Codes/Mitigation Info/Possible Solution		Field Measurements/Component Compliance

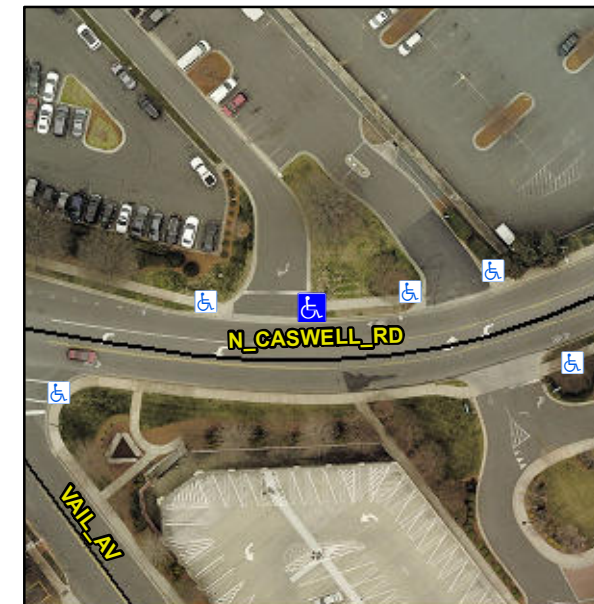
Compliance	Description	Data	Compliance	Description	Data
N/A	Ramp Length (in)	49.0	N/A	Grade Break?	N/A
Yes	Ramp Width (in)	48.0	N/A	Grade Break Slope (%)	0.0
Yes	Ramp Slope (%)	2.6	N/A	Grade Break XSlope (%)	0.0
No	Ramp XSlope (%)	5.1			
N/A	Flare Type LT	N/A	N/A	Flare Type RT	N/A
N/A	Flare Slope LT (%)	N/A	N/A	Flare Slope RT (%)	0.0
N/A	Flare Traversable LT?	N/A	N/A	Flare Traversable RT?	N/A
N/A	Landing Length (in)	0.0	N/A	DWS Provided?	N/A
N/A	Landing Width (in)	0.0	N/A	DWS Contrast?	N/A
N/A	Landing Slope (%)	0.0	N/A	DWS Length (in)	N/A
N/A	Landing X Slope (%)	0.0	N/A	DWS Full Width?	N/A
N/A	Landing Curb? (Y/N)	N/A	N/A	DWS Offset LT (in)	N/A
N/A	Shared Landing?	N/A	N/A	DWS Offset RT (in)	N/A
N/A	Gutter Ponding?	0.0	N/A	Gutter Slope (%)	N/A
N/A	Gutter Lip Ht (in)	0.0	N/A	Gutter X Slope (%)	N/A
N/A	Painted X Walk1?	No		Road Slope (%)	2.9
	X Walk 1 Direction	To SW		Road X Slope (%)	7.5
	X Walk 1 Width (in)	N/A		Clear Space?	N/A

X Walk 1 Slope (%)	2.9	N/A	Clear Space to XWalk (in)	N/A
	X Walk 1 X Slope (%)	7.5	N/A	Storm Grate/Utility Hazard?	N/A
N/A	Ramp inside XWalk1?	N/A		Storm Grate/Utility Type	
N/A	Any Obstructions?	N/A			N/A
	Obstruction Type		Yes	Surface Condition? (G/P)	Good
			N/A	Curb Slope (%)	4.0

Remove & Replace Entire Ramp.

R304.5.3
