## Access Compliance Report Public Rights-of-Way (Curb Ramps)

Intersection ID: 48763 Main Street: SONOMA\_VALLEY\_DR Cross Street: N/A Location: E

ADA ID: D1F7F872DE3D Ramp Type: Perp Initial Pass/Fail: Fail Overall Compliance: No Severity Score: 22.5

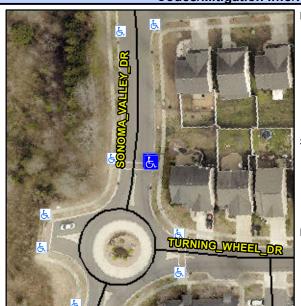
Not Found, R304.5.1, R304.2.2,
R304.5.3

Field Measurements/Component Compliance						
Compli	ance Description	Data	Compl	liance	Description	Data
N/A	Ramp Length (in)	71.5	No	Ramp	Slope (%)	9.9
No	Ramp Width (in)	47.5	No	Ramp	XSlope (%)	2.5
N/A	Flare Type LT	N/A	N/A	Flare 1	Гуре RT	N/A
N/A	Flare Slope LT (%)	N/A	N/A	Flare S	Slope RT (%)	N/A
N/A	Flare Traversable LT?	N/A	N/A	Flare 1	Traversable RT?	N/A
N/A	Landing Length (in)	N/A	N/A	DWS F	Provided?	N/A
N/A	Landing Width (in)	N/A	N/A	DWS (	Contrast?	N/A
N/A	Landing Slope (%)	N/A	N/A	DWS I	_ength (in)	N/A
N/A	Landing X Slope (%)	N/A	N/A	DWS F	Full Width?	N/A
N/A	Landing Curb? (Y/N)	N/A	N/A	DWS (	Offset (in)	N/A
N/A	Shared Landing?	N/A				
N/A	Gutter Ponding?	N/A	N/A	Gutter	Slope (%)	N/A
N/A	Gutter Lip Ht (in)	N/A	N/A	Gutter	X Slope (%)	N/A
N/A	Painted X Walk1?	Yes	N/A	Painte	d X Walk2?	N/A
	X Walk 1 Direction	To W		X Wall	k 2 Direction	N/A
N/A	X Walk 1 Width (in)	75.0	N/A	X Wall	c 2 Width (in)	N/A

X Walk 1 Slope (%)	0.4		X Wall	< 2 Slope (%)	N/A
	X Walk 1 X Slope (%)	1.1		X Wall	< 2 X Slope (%)	N/A
N/A	Ramp inside XWalk1?	Yes	N/A	Ramp	inside XWalk2?	N/A
	Road Slope (%)	N/A	N/A	Clear	Space?	N/A
	Road X Slope (%)	N/A	N/A	Clear	Space to XWalk (in)	N/A
N/A	Any Obstructions?	N/A	N/A	Storm	Grate/Utility Hazard?	N/A
	Obstruction Type			Storm	Grate/Utility Type	
		N/A				N/A
			Yes	Surfac	e Condition? (G/P)	Good
dilla brai	and the same of th

Remove & Replace Entire Ramp.

Total Cost: \$ 1850.00
