# Access Compliance Report

## Public Rights-of-Way

| Intersection ID: 28235 | Main Street: LANDING_GREEN_DR | Cross Street: LYNDONVILLE_DR | Location: NE |
| ADA ID: D2079EC23061 | Ramp Type: PerpDiag | Initial Pass/Fail: Pass | Overall Compliance: No |

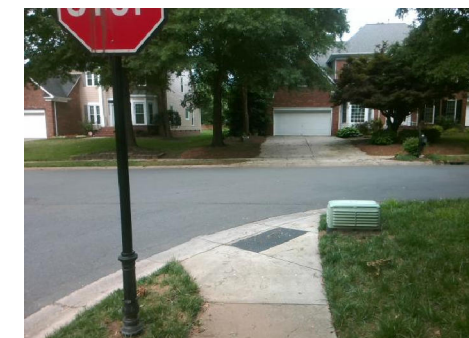
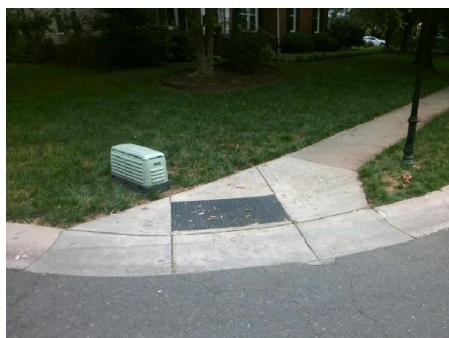
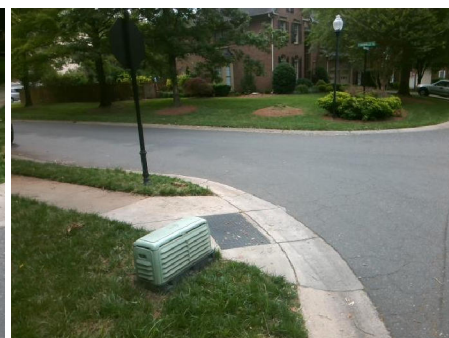
| Severity Score: 10.25 | | | |

**Not Found, R304.5.3, R304.2.1, R304.2.2-Perp, R304.3.2-Para, R305.2**

| Compliance | Description | Data | Compliance | Description | Data |
|---|---|---|---|---|---|
| Yes | Ramp Width (in) | 48.0 | No | Ramp XSlope (%) | 2.1 |
| No | Landing Length (in) | N/A | Yes | DWS Provided? | Yes |
| No | Landing Width (in) | N/A | Yes | DWS Contrast? | Yes |
| No | Landing Slope (%) | N/A | Yes | DWS Length (in) | 24.0 |
| No | Landing X Slope (%) | N/A | Yes | DWS Full Width? | Yes |
| N/A | Landing Curb? (Y/N) | No | No | DWS Offset (in) | 3.0 |

**Remove & Replace Curb Ramp With Two New Directional Ramps or Equivalent.**

Total Cost: \$ 3200.00
