Access Compliance Report Public Rights-of-Way (Curb Ramps)

Intersection ID: 19390 Main Street: VILLAGE_LAKE_DR **Cross Street: WOODSCAPE_DR** Location: NW **Overall Compliance: No Severity Score:** ADA ID: D208030F200F Ramp Type: PerpDiag Initial Pass/Fail: Fail 37.5

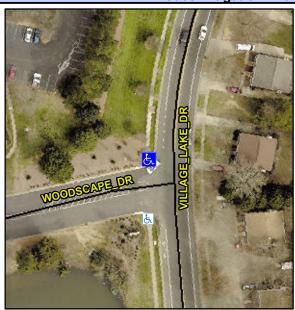
Field Measurements/Component Compliance						
Compliance Description		Data	Comp	liance Description	Data	
N/A	Ramp Length (in)	73.5	No	Ramp Slope (%)	12.0	
Yes	Ramp Width (in)	48.0	No	Ramp XSlope (%)	6.2	
N/A	Flare Type LT	N/A	N/A	Flare Type RT	N/A	
N/A	Flare Slope LT (%)	N/A	N/A	Flare Slope RT (%)	N/A	
N/A	Flare Traversable LT?	N/A	N/A	Flare Traversable RT?	N/A	
N/A	Landing Length (in)	N/A	N/A	DWS Provided?	N/A	
N/A	Landing Width (in)	N/A	N/A	DWS Contrast?	N/A	
N/A	Landing Slope (%)	N/A	N/A	DWS Length (in)	N/A	
N/A	Landing X Slope (%)	N/A	N/A	DWS Full Width?	N/A	
N/A	Landing Curb? (Y/N)	N/A	N/A	DWS Offset (in)	N/A	
N/A	Shared Landing?	N/A				
N/A	Gutter Ponding?	N/A	N/A	Gutter Slope (%)	N/A	
N/A	Gutter Lip Ht (in)	N/A	N/A	Gutter X Slope (%)	N/A	
N/A	Painted X Walk1?	No	N/A	Painted X Walk2?	No	
	X Walk 1 Direction	To S		X Walk 2 Direction	To E	
N/A	X Walk 1 Width (in)	N/A	N/A	X Walk 2 Width (in)	N/A	
	X Walk 1 Slope (%)	2.8		X Walk 2 Slope (%)	2.5

X Walk 1 X Slope (%)	2.9		X Walk 2 X Slope (%)	3.4	
N/A	Ramp inside XWalk1?	N/A	N/A	Ramp inside XWalk2?	N/A	
	Road Slope (%)	4.8	N/A	Clear Space?	N/A	
	Road X Slope (%)	0.8	N/A	Clear Space to XWalk (in)	N/A	
N/A	Any Obstructions?	N/A	N/A	Storm Grate/Utility Hazard?	N/A	
	Obstruction Type			Storm Grate/Utility Type		
		N/A			N/A	
			Yes	Surface Condition? (G/P)	Good

Possible Solutions:
Remove & Replace Curb Ramp With Two New Directional Ramps or Equivalent.
Surveyor Notes: N/A
PROW/ADA: Not Found, R304.2.2, R304.5.3

Total Cost: 3200.00
