# Access Compliance Report

## Public Rights-of-Way

### (Curb Ramps)

| Intersection ID: 8367 | Main Street: KENTUCKY_AV | Cross Street: NELSON_AV | Location: NE |

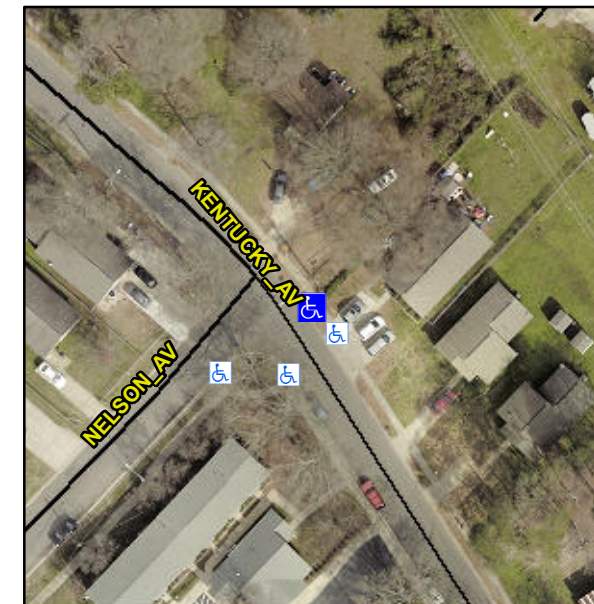
| Compliance | Description | Data | Compliance | Description | Data |
|---|---|---|---|---|---|
| Yes | Landing Length (in) | 60.0 | No | DWS Provided? | No |
| Yes | Gutter Ponding? | No | No | Gutter Slope (%) | 11.7 |
| | | | No | Curb Slope (%) | 32.7 |

**Remove & Replace Curb Ramp With Two New Directional Ramps or Equivalent. Remove & Replace Gutter.**

**Not Found, R305, R304.5.4**
