# Access Compliance Report

## Public Rights-of-Way

### (Curb Ramps)

| Intersection ID: 20312 | Main Street: SPRINGWOOD_LN | Cross Street: WICKER_DR | Location: E |

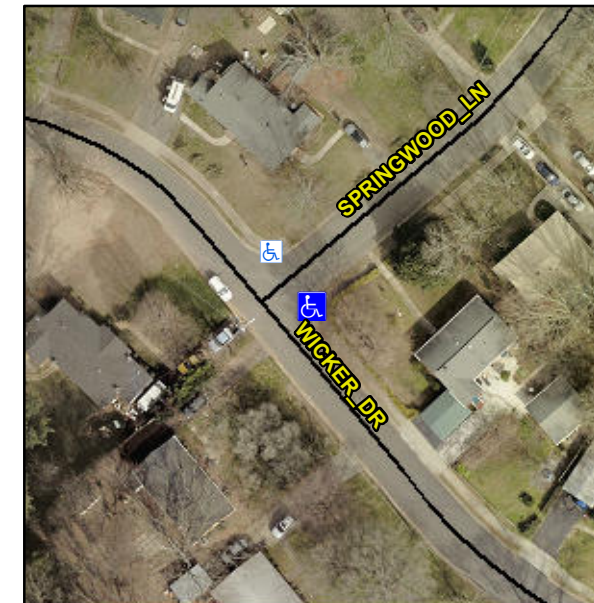
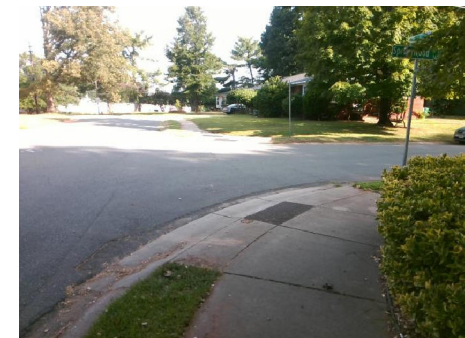
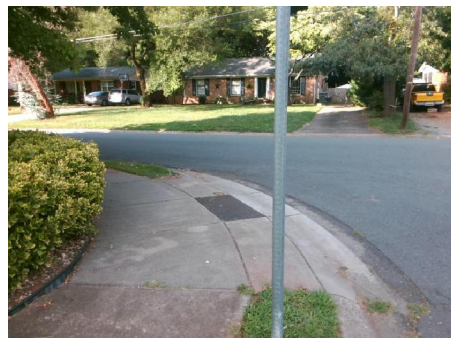
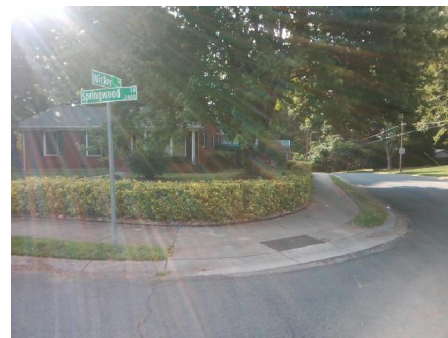
| ADA ID: D21AC9DD1A85 | Ramp Type: BlendTrans1 | Initial Pass/Fail: Pass | Overall Compliance: No |
| | | Severity Score: 7.5 | |

**Not Found, R302.7.2**

| Compliance | Description | Data | Compliance | Description | Data |
|---|---|---|---|---|---|
| No | Gutter Lip Ht (in) | 0.5 | Yes | Gutter X Slope (%) | 0.9 |
| | | | No | Curb Slope (%) | 23.8 |

**Remove & Replace Curb Slope and Extend Ramp.**

Total Cost: \$ 2000.00
