Access Compliance Report

Public Rights-of-Way (Curb Ramps)

Intersection ID: 22686	Main Street: INDIAN_HILLS_LN	Cross Street: MAPLE_SPRING_DR	Location: W
ADA ID: D21EC8018235	Ramp Type: Directional1	Initial Pass/Fail: Fail	Overall Compliance: No
		Severity Score: 22.5

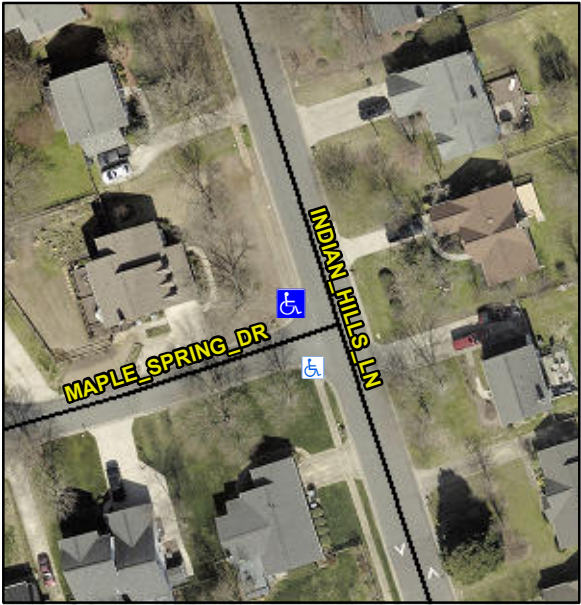
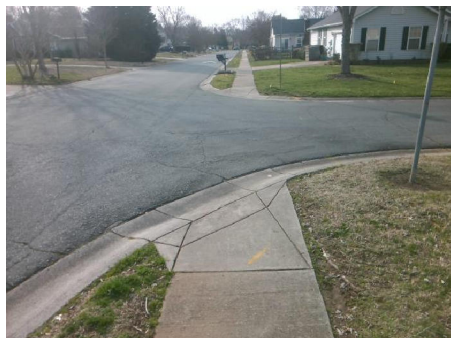
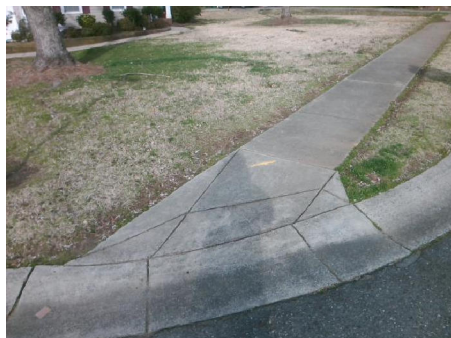
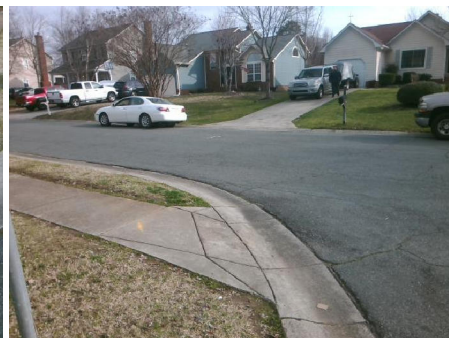
Possible Solutions:		Compliance	Description	Data	
	Remove & Replace Entire Ramp.		N/A	Ramp Length (in)	40.0	N/A
			No	Ramp Width (in)	46.0	N/A
			No	Ramp Slope (%)	9.8	N/A
			No	Ramp XSlope (%)	3.3	N/A
			N/A	Flare Type LT	N/A	N/A
			N/A	Flare Slope LT (%)	N/A	N/A
			N/A	Flare Traversable LT?	N/A	N/A
			N/A	Landing Length (in)	0.0	N/A
			N/A	Landing Width (in)	0.0	N/A
			N/A	Landing Slope (%)	0.0	N/A
			N/A	Landing X Slope (%)	0.0	N/A
			N/A	Landing Curb? (Y/N)	N/A	N/A
			N/A	Shared Landing?	N/A	N/A
			N/A	Gutter Ponding?	0.0	N/A
			N/A	Gutter Lip Ht (in)	0.0	N/A
			N/A	Painted X Walk1?	No	N/A
				X Walk 1 Direction	To SE	N/A
				X Walk 1 Width (in)	N/A	N/A
				X Walk 1 Slope (%)	2.0	N/A
				X Walk 1 X Slope (%)	3.4	N/A
<p>Surveyor Notes:</p> <p>N/A</p>			N/A	Ramp inside XWalk1?	N/A	N/A
			N/A	Any Obstructions?	N/A	N/A
<p>PROW/ADA:</p> <p>R304.5.1, R304.2.2, R304.5.3</p>				Obstruction Type

Yes	Surface Condition? (G/P)		Good
			N/A	Curb Slope (%)		13.6
Street 1 Name	MAPLE SPRING DR					
Stop Condition-Street 1	StopSign					
Street 2 Name	N/A					
Stop Condition-Street 2	N/A					
Total Cost:	\$ 1600.00
