Access Compliance Report Public Rights-of-Way (Curb Ramps)

| | | | | _ | | | | | | |
|---|---|---|---|--|---|---|---|---|---|--|
| Intersection ID: 47138 | Main Street: SAVANNAH_HILLS_DR | | | Cross Street: HABITAT_MANOR_DR | | | | Location: | N | |
| ADA ID: D2244EB3F9D3 | Ramp Type: Perp | | | Initial Pass/Fail: Fail Overall Compliance | | | | o Severity Score: | 8.75 | |

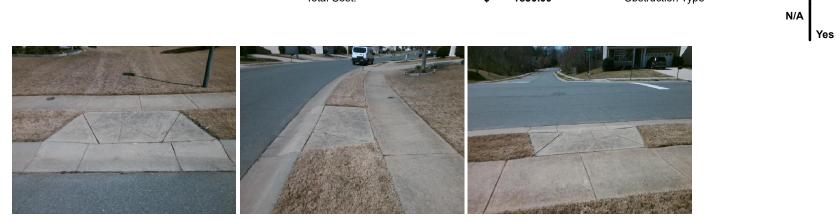
| | | | | _ | | | | | | |
|---|---|---|---|--|---|---|---|---|---|--|
| LAND THE | N. Carl | | | No | Ramp Width (in) | 39.0 | Yes | Ramp XSlope (%) | 1.5 | |
| States and a | No. | Not Found, R304.5.1 | | N/A | Gutter Lip Ht (in) | N/A | N/A | Gutter X Slope (%) | N/A | |

| | | | | _ | | | | | | |
|---|---|---|---|--|---|---|---|---|---|--|
| | 1 13. | Remove & Replace Entire Ramp | | N/A | Ramp Length (in) | 48.0 | Yes | Ramp Slope (%) | 5.4 | |
| | | Total Cost: \$ | 850.00 | | Obstruction Type | | | Storm Grate/Utility Type | | |
