Access Compliance Report

Public Rights-of-Way

(Curb Ramps)

| Intersection ID: 16207 | Main Street: MONROE_RD | Cross Street: COMMODORE_ST | Location: SE |

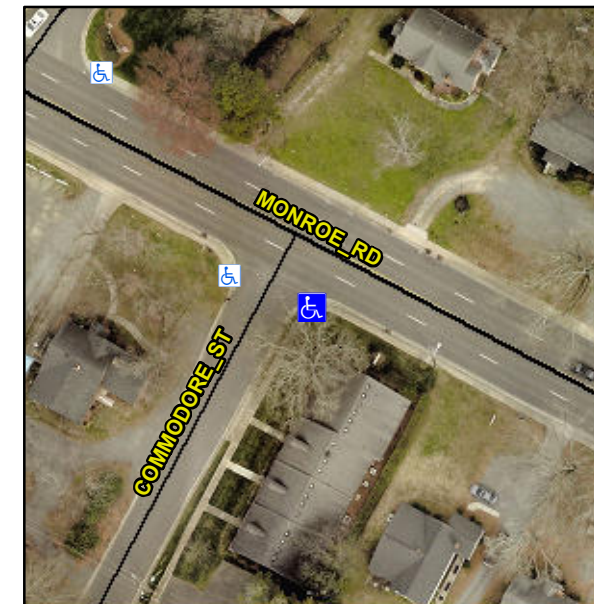
| ADA ID: D2407E368E60 | Ramp Type: ParaDiag | Initial Pass/Fail: Fail | Overall Compliance: No |

| Compliance | Description | Data | Compliance | Description | Data |
|---|---|---|---|---|---|
| No | Ramp Width LT (in) | 36.0 | No | Ramp Width RT (in) | 46.0 |
| No | Ramp Slope LT (%) | 9.0 | No | Ramp Slope RT (%) | 9.3 |
| Yes | Ramp XSlope LT (%) | 0.3 | No | Ramp XSlope RT (%) | 2.6 |

Remove & Replace Curb Ramp With Two New Directional Ramps or Equivalent.

R304.5.1, R304.3.2, R304.5.3
