Access Compliance Report

Public Rights-of-Way

(Curb Ramps)

Intersection ID: N/A	Main Street: E_4TH_ST	Cross Street: N/A	Location: NW
ADA ID: D241EA1A7C89	Ramp Type: Perp	Initial Pass/Fail: Fail	Overall Compliance: No
		Severity Score: 25

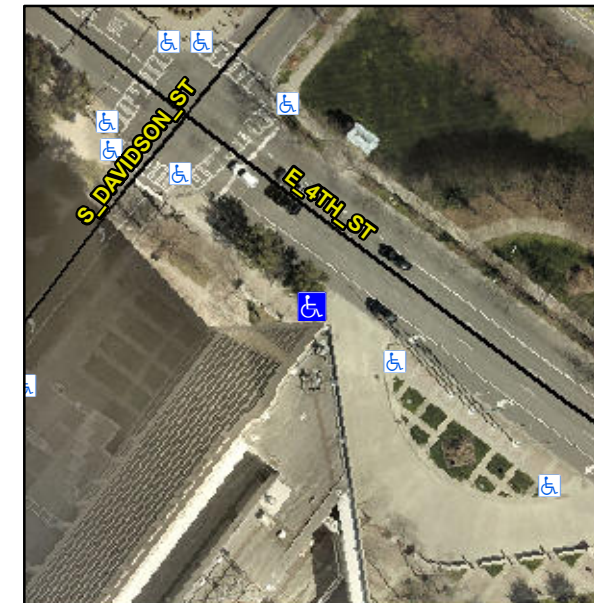
Compliance	Description	Data	Compliance	Description	Data
N/A	Ramp Length (in)	75.0	No	Ramp Slope (%)	13.4
Yes	Ramp Width (in)	72.0	Yes	Ramp XSlope (%)	0.5
N/A	Flare Type LT	N/A	N/A	Flare Type RT	N/A
N/A	Flare Slope LT (%)	N/A	N/A	Flare Slope RT (%)	N/A
N/A	Flare Traversable LT?	No	N/A	Flare Traversable RT?	No
N/A	Landing Length (in)	N/A	N/A	DWS Provided?	N/A
N/A	Landing Width (in)	N/A	N/A	DWS Contrast?	N/A
N/A	Landing Slope (%)	N/A	N/A	DWS Length (in)	N/A
N/A	Landing X Slope (%)	N/A	N/A	DWS Full Width?	N/A
N/A	Landing Curb? (Y/N)	N/A	N/A	DWS Offset (in)	N/A
N/A	Shared Landing?	N/A			
N/A	Gutter Ponding?	N/A	N/A	Gutter Slope (%)	N/A
N/A	Gutter Lip Ht (in)	N/A	N/A	Gutter X Slope (%)	N/A
N/A	Painted X Walk1?	No	N/A	Painted X Walk2?	N/A
	X Walk 1 Direction	To SE		X Walk 2 Direction	N/A
N/A	X Walk 1 Width (in)	N/A	N/A	X Walk 2 Width (in)	N/A
	X Walk 1 Slope (%)	0.5		X Walk 2 Slope (%)	N/A
	X Walk 1 X Slope (%)	0.1		X Walk 2 X Slope (%)	N/A

Remove & Replace Entire Ramp.

R304.2.2
