Intersection ID: 17261	Main Street: LYNNWOOD_DR	Cross Street: WESTFIELD_RD	Location:	SE
ADA ID: D24716317C7A	Ramp Type: PerpDiag	Initial Pass/Fail: Fail	Overall Compliance: No	Severity Score: 12.5

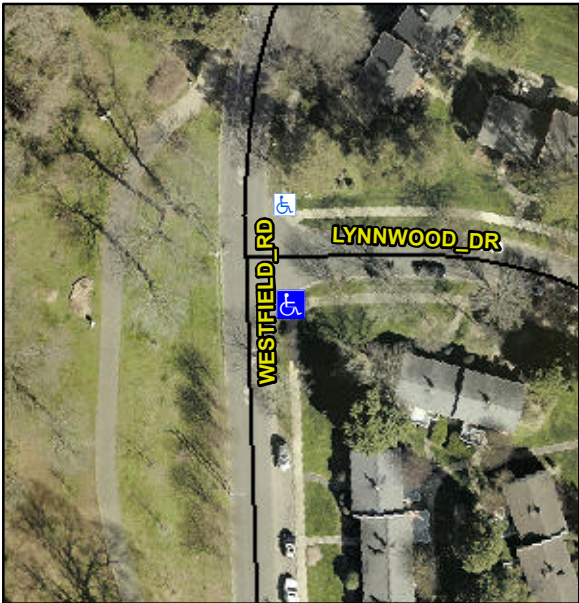
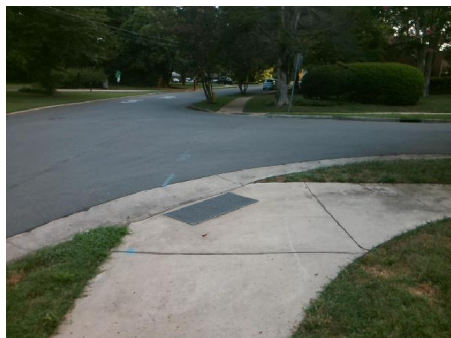
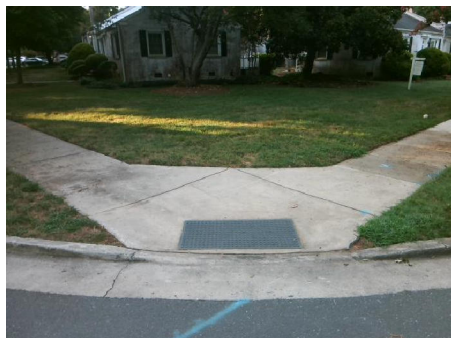
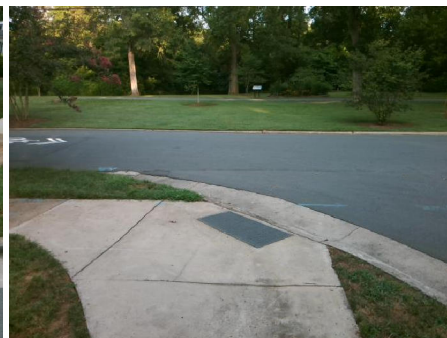
Possible Solutions:		Compliance	Description	Data	Compliance	Description	Data
	Remove & Replace Curb Ramp With Two New Directional Ramps or Equivalent.		N/A	Ramp Length (in)	101.0	Yes	Ramp Slope (%)	5.4
			Yes	Ramp Width (in)	54.0	No	Ramp XSlope (%)	5.2
			N/A	Flare Type LT	N/A	N/A	Flare Type RT	N/A
			N/A	Flare Slope LT (%)	N/A	N/A	Flare Slope RT (%)	N/A
			N/A	Flare Traversable LT?	N/A	N/A	Flare Traversable RT?	N/A
			N/A	Landing Length (in)	N/A	N/A	DWS Provided?	N/A
			N/A	Landing Width (in)	N/A	N/A	DWS Contrast?	N/A
			N/A	Landing Slope (%)	N/A	N/A	DWS Length (in)	N/A
			N/A	Landing X Slope (%)	N/A	N/A	DWS Full Width?	N/A
Surveyor Notes:		N/A	N/A	Landing Curb? (Y/N)	N/A	N/A	DWS Offset (in)	N/A
PROW/ADA:		R304.5.3	N/A	Shared Landing?	N/A			
			N/A	Gutter Ponding?	N/A	N/A	Gutter Slope (%)	N/A
			N/A	Gutter Lip Ht (in)	N/A	N/A	Gutter X Slope (%)	N/A

N/A	Painted X Walk1?	No	N/A	Painted X Walk2?	No
				X Walk 1 Direction	To N		X Walk 2 Direction	To W
			N/A	X Walk 1 Width (in)	N/A	N/A	X Walk 2 Width (in)	N/A
				X Walk 1 Slope (%)	5.4		X Walk 2 Slope (%)	2.2
				X Walk 1 X Slope (%)	0.1		X Walk 2 X Slope (%)	2.0
			N/A	Ramp inside XWalk1?	N/A	N/A	Ramp inside XWalk2?	N/A
				Road Slope (%)	1.5	N/A	Clear Space?	N/A
				Road X Slope (%)	0.9	N/A	Clear Space to XWalk (in)	N/A
			N/A	Any Obstructions?	N/A	N/A	Storm Grate/Utility Hazard?	N/A
				Obstruction Type			Storm Grate/Utility Type	
					N/A			N/A
						Yes	Surface Condition? (G/P)	Good
Street 1 Name			LYNNWOOD DR					
Stop Condition-Street 2			StopSign					
Street 2 Name			WESTFIELD RD					
Stop Condition-Street 1			None					
Total Cost:			\$	3200.00
