Access Compliance Report

Public Rights-of-Way

(Curb Ramps)

Intersection ID: 21320	Main Street: FREDERICK_PL	Cross Street: PARK_RD	Location:	NE
ADA ID: D24DD6F4FE83	Ramp Type: PerpDiag	Initial Pass/Fail: Fail	Overall Compliance: No	Severity Score: 10
Codes/Mitigation Info/Possible Solution		Field Measurements/Component Compliance

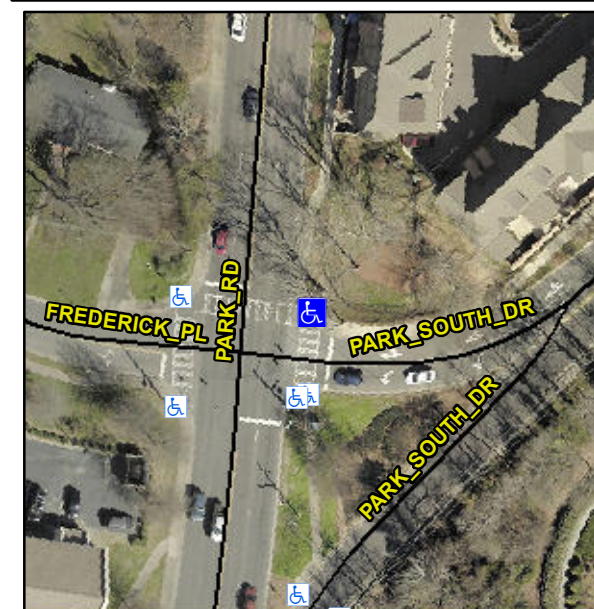
Not Found, R304.5.1, R304.5.3

Compliance	Description	Data	Compliance	Description	Data
N/A	Ramp Length (in)	58.0	Yes	Ramp Slope (%)	7.7
No	Ramp Width (in)	36.0	No	Ramp XSlope (%)	2.5
N/A	Flare Type LT	N/A	N/A	Flare Type RT	N/A
N/A	Flare Slope LT (%)	N/A	N/A	Flare Slope RT (%)	N/A
N/A	Flare Traversable LT?	N/A	N/A	Flare Traversable RT?	N/A
N/A	Landing Length (in)	N/A	N/A	DWS Provided?	N/A
N/A	Landing Width (in)	N/A	N/A	DWS Contrast?	N/A
N/A	Landing Slope (%)	N/A	N/A	DWS Length (in)	N/A
N/A	Landing X Slope (%)	N/A	N/A	DWS Full Width?	N/A
N/A	Landing Curb? (Y/N)	N/A	N/A	DWS Offset (in)	N/A
N/A	Shared Landing?	N/A			
N/A	Gutter Ponding?	N/A	N/A	Gutter Slope (%)	N/A
N/A	Gutter Lip Ht (in)	N/A	N/A	Gutter X Slope (%)	N/A
N/A	Painted X Walk1?	Yes	N/A	Painted X Walk2?	Yes
	X Walk 1 Direction	To NW		X Walk 2 Direction	To SW
N/A	X Walk 1 Width (in)	110.0	N/A	X Walk 2 Width (in)	110.0
	X Walk 1 Slope (%)	2.3		X Walk 2 Slope (%)	1.2
	X Walk 1 X Slope (%)	3.4		X Walk 2 X Slope (%)	1.1

N/A	Ramp inside XWalk1?	Yes	N/A	Ramp inside XWalk2?	Yes
	Road Slope (%)	1.0	N/A	Clear Space?	N/A
	Road X Slope (%)	0.6	N/A	Clear Space to XWalk (in)	N/A
N/A	Any Obstructions?	N/A	N/A	Storm Grate/Utility Hazard?	N/A
	Obstruction Type			Storm Grate/Utility Type	
		N/A			N/A
		Yes		Surface Condition? (G/P)	Good

Possible Solutions:

Remove & Replace Curb Ramp With Two New Directional Ramps or Equivalent.
