Access Compliance Report

Public Rights-of-Way

(Curb Ramps)

Intersection ID: 14396	Main Street: BRIAR_CREEK_RD	Cross Street: COMMONWEALTH_AV	Location: E
ADA ID: D25A5FFD598F	Ramp Type: PerpDiag	Initial Pass/Fail: Fail	Overall Compliance: No
Severity Score: 22.5			
Codes/Mitigation Info/Possible Solution		Field Measurements/Component Compliance

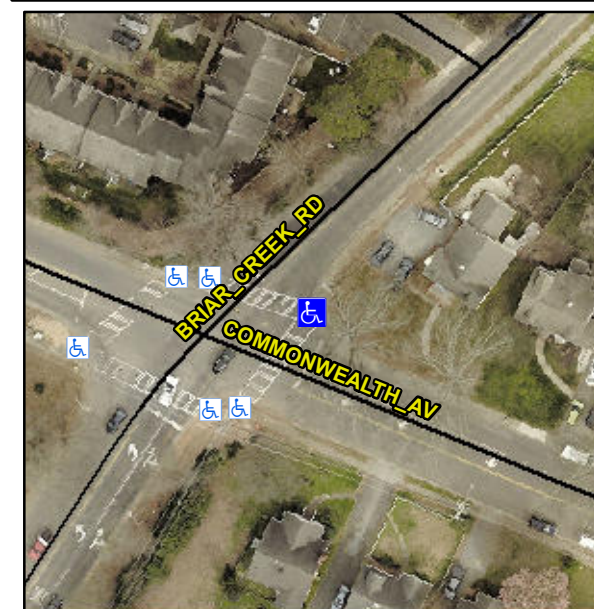
Not Found, R304.5.1, R304.2.2, R304.5.3

Compliance	Description	Data	Compliance	Description	Data
N/A	Ramp Length (in)	60.0	No	Ramp Slope (%)	9.4
No	Ramp Width (in)	39.5	No	Ramp XSlope (%)	4.8
N/A	Flare Type LT	N/A	N/A	Flare Type RT	N/A
N/A	Flare Slope LT (%)	N/A	N/A	Flare Slope RT (%)	N/A
N/A	Flare Traversable LT?	N/A	N/A	Flare Traversable RT?	N/A
N/A	Landing Length (in)	N/A	N/A	DWS Provided?	N/A
N/A	Landing Width (in)	N/A	N/A	DWS Contrast?	N/A
N/A	Landing Slope (%)	N/A	N/A	DWS Length (in)	N/A
N/A	Landing X Slope (%)	N/A	N/A	DWS Full Width?	N/A
N/A	Landing Curb? (Y/N)	N/A	N/A	DWS Offset (in)	N/A
N/A	Shared Landing?	N/A			
N/A	Gutter Ponding?	N/A	N/A	Gutter Slope (%)	N/A
N/A	Gutter Lip Ht (in)	N/A	N/A	Gutter X Slope (%)	N/A
N/A	Painted X Walk1?	Yes	N/A	Painted X Walk2?	Yes
	X Walk 1 Direction	To NW		X Walk 2 Direction	To SW
N/A	X Walk 1 Width (in)	111.0	N/A	X Walk 2 Width (in)	111.0
	X Walk 1 Slope (%)	0.2		X Walk 2 Slope (%)	3.6
	X Walk 1 X Slope (%)	4.5		X Walk 2 X Slope (%)	1.0

N/A	Ramp inside XWalk1?	Yes	N/A	Ramp inside XWalk2?	Yes
	Road Slope (%)	4.2	N/A	Clear Space?	N/A
	Road X Slope (%)	1.2	N/A	Clear Space to XWalk (in)	N/A
N/A	Any Obstructions?	N/A	N/A	Storm Grate/Utility Hazard?	N/A
	Obstruction Type			Storm Grate/Utility Type	
		N/A			N/A
		Yes		Surface Condition? (G/P)	Good

Possible Solutions:

Remove & Replace Curb Ramp With Two New Directional Ramps or Equivalent.
