# Access Compliance Report

## Public Rights-of-Way

### (Curb Ramps)

Intersection ID: 17651	Main Street: CHELSEA_DR	Cross Street: HILLSIDE_AV	Location: NW
ADA ID: D25EE3CC29CF	Ramp Type: Directional1	Initial Pass/Fail: Fail	Overall Compliance: No
			Severity Score: 13.75

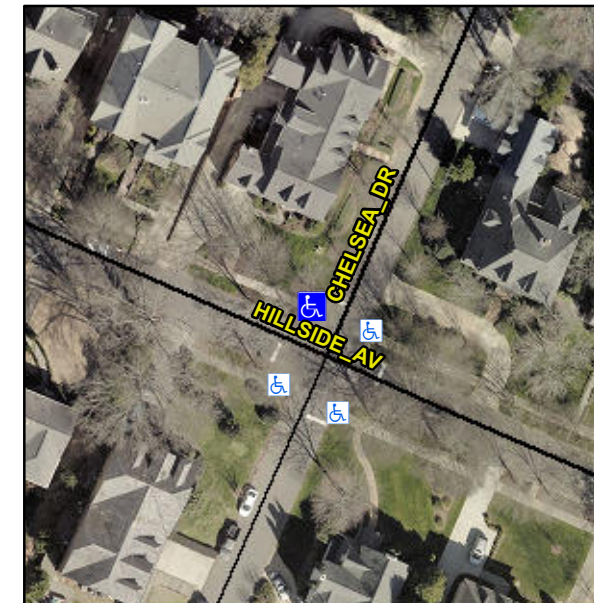
**ASP COVERING CURB**

**R304.2.2, R304.5.3**

Compliance	Description	Data	Compliance	Description	Data
N/A	Ramp Length (in)	72.0	N/A	Grade Break?	N/A
Yes	Ramp Width (in)	60.0	N/A	Grade Break Slope (%)	0.0
No	Ramp Slope (%)	10.2	N/A	Grade Break XSlope (%)	0.0
No	Ramp XSlope (%)	2.2			
N/A	Flare Type LT	N/A	N/A	Flare Type RT	N/A
N/A	Flare Slope LT (%)	N/A	N/A	Flare Slope RT (%)	0.0
N/A	Flare Traversable LT?	N/A	N/A	Flare Traversable RT?	N/A
N/A	Landing Length (in)	0.0	N/A	DWS Provided?	N/A
N/A	Landing Width (in)	0.0	N/A	DWS Contrast?	N/A
N/A	Landing Slope (%)	0.0	N/A	DWS Length (in)	N/A
N/A	Landing X Slope (%)	0.0	N/A	DWS Full Width?	N/A
N/A	Landing Curb? (Y/N)	N/A	N/A	DWS Offset LT (in)	N/A
N/A	Shared Landing?	N/A	N/A	DWS Offset RT (in)	N/A
N/A	Gutter Ponding?	Yes	N/A	Gutter Slope (%)	N/A
N/A	Gutter Lip Ht (in)	0.0	N/A	Gutter X Slope (%)	N/A
N/A	Painted X Walk1?	No		Road Slope (%)	1.4
	X Walk 1 Direction	To E		Road X Slope (%)	1.3
	X Walk 1 Width (in)	N/A		Clear Space?	N/A

X Walk 1 Slope (%)	1.4	N/A	Clear Space to XWalk (in)	N/A
	X Walk 1 X Slope (%)	1.3	N/A	Storm Grate/Utility Hazard?	N/A
N/A	Ramp inside XWalk1?	N/A		Storm Grate/Utility Type	
N/A	Any Obstructions?	N/A			N/A
	Obstruction Type		Yes	Surface Condition? (G/P)	Good
			N/A	Curb Slope (%)	N/A

**Remove & Replace Entire Ramp.**

Total Cost: \$ 1600.00
