Access Compliance Report

Public Rights-of-Way

(Curb Ramps)

Intersection ID: 11698	Main Street: S_CEDAR_ST	Cross Street: W_4TH_ST	Location: E
ADA ID: D268F5773385	Ramp Type: PerpDiag	Initial Pass/Fail: Fail	Overall Compliance: No
Severity Score: 13.75			
Codes/Mitigation Info/Possible Solution		Field Measurements/Component Compliance

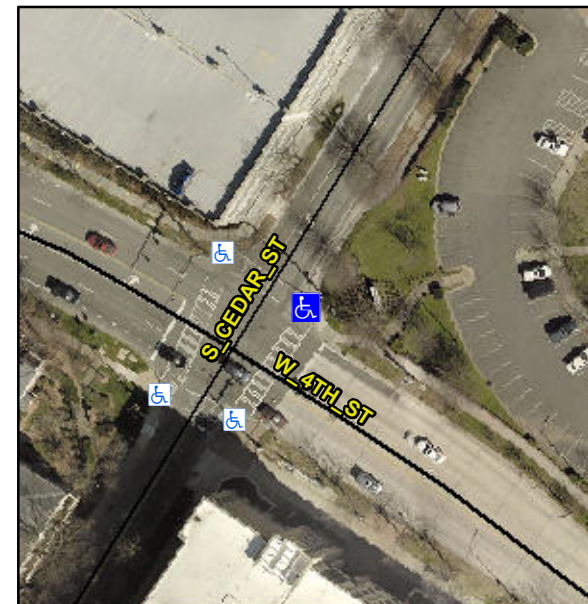
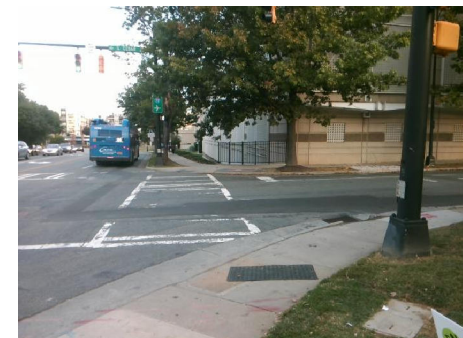
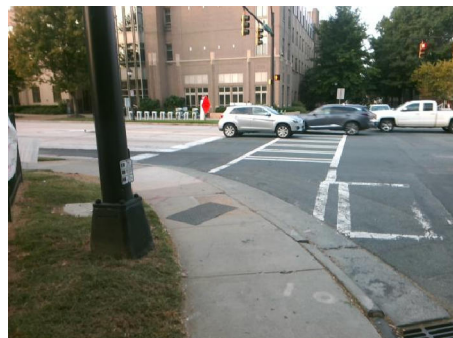
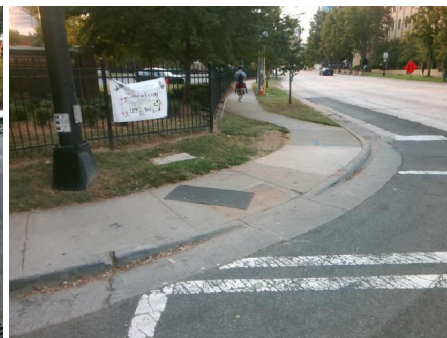
R304.2.2, R304.5.3

Compliance	Description	Data	Compliance	Description	Data
N/A	Ramp Length (in)	64.0	No	Ramp Slope (%)	9.1
Yes	Ramp Width (in)	58.0	No	Ramp XSlope (%)	3.8
N/A	Flare Type LT	N/A	N/A	Flare Type RT	N/A
N/A	Flare Slope LT (%)	N/A	N/A	Flare Slope RT (%)	N/A
N/A	Flare Traversable LT?	N/A	N/A	Flare Traversable RT?	N/A
N/A	Landing Length (in)	N/A	N/A	DWS Provided?	N/A
N/A	Landing Width (in)	N/A	N/A	DWS Contrast?	N/A
N/A	Landing Slope (%)	N/A	N/A	DWS Length (in)	N/A
N/A	Landing X Slope (%)	N/A	N/A	DWS Full Width?	N/A
N/A	Landing Curb? (Y/N)	N/A	N/A	DWS Offset (in)	N/A
N/A	Shared Landing?	N/A			
N/A	Gutter Ponding?	N/A	N/A	Gutter Slope (%)	N/A
N/A	Gutter Lip Ht (in)	N/A	N/A	Gutter X Slope (%)	N/A
N/A	Painted X Walk1?	Yes	N/A	Painted X Walk2?	Yes
	X Walk 1 Direction	To NW		X Walk 2 Direction	To SW
N/A	X Walk 1 Width (in)	110.0	N/A	X Walk 2 Width (in)	109.0
	X Walk 1 Slope (%)	1.0		X Walk 2 Slope (%)	0.4
	X Walk 1 X Slope (%)	1.3		X Walk 2 X Slope (%)	1.2

N/A	Ramp inside XWalk1?	Yes	N/A	Ramp inside XWalk2?	Yes
	Road Slope (%)	1.5	N/A	Clear Space?	N/A
	Road X Slope (%)	1.8	N/A	Clear Space to XWalk (in)	N/A
N/A	Any Obstructions?	N/A	N/A	Storm Grate/Utility Hazard?	N/A
	Obstruction Type			Storm Grate/Utility Type	
		N/A			N/A
		Yes		Surface Condition? (G/P)	Good

Remove & Replace Curb Ramp With Two New Directional Ramps or Equivalent.
